THE RESTORATION OF
ITUM BAH
FINAL REPORT | OCTOBER 2017

SUBMITTED TO ORIENTAL CULTURAL HERITAGE SITES PROTECTION ALLIANCE, FRANCE

IMPLEMENTED BY THE KATHMANDU VALLEY PRESERVATION TRUST

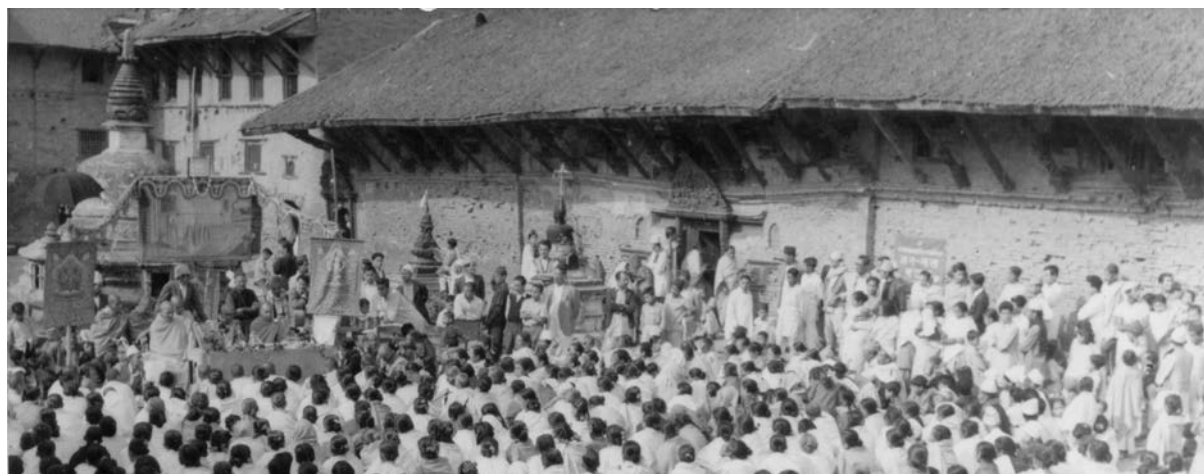
Historic view of Itumbaha's East Wing | pre 1934

This undated photograph was most likely taken before the great earthquake of 1934. Already in poor structural condition as indicated by the sagging central section of the building, the monastery still retains its original square shape. The ground floor has no other doors and windows except the central entrance.

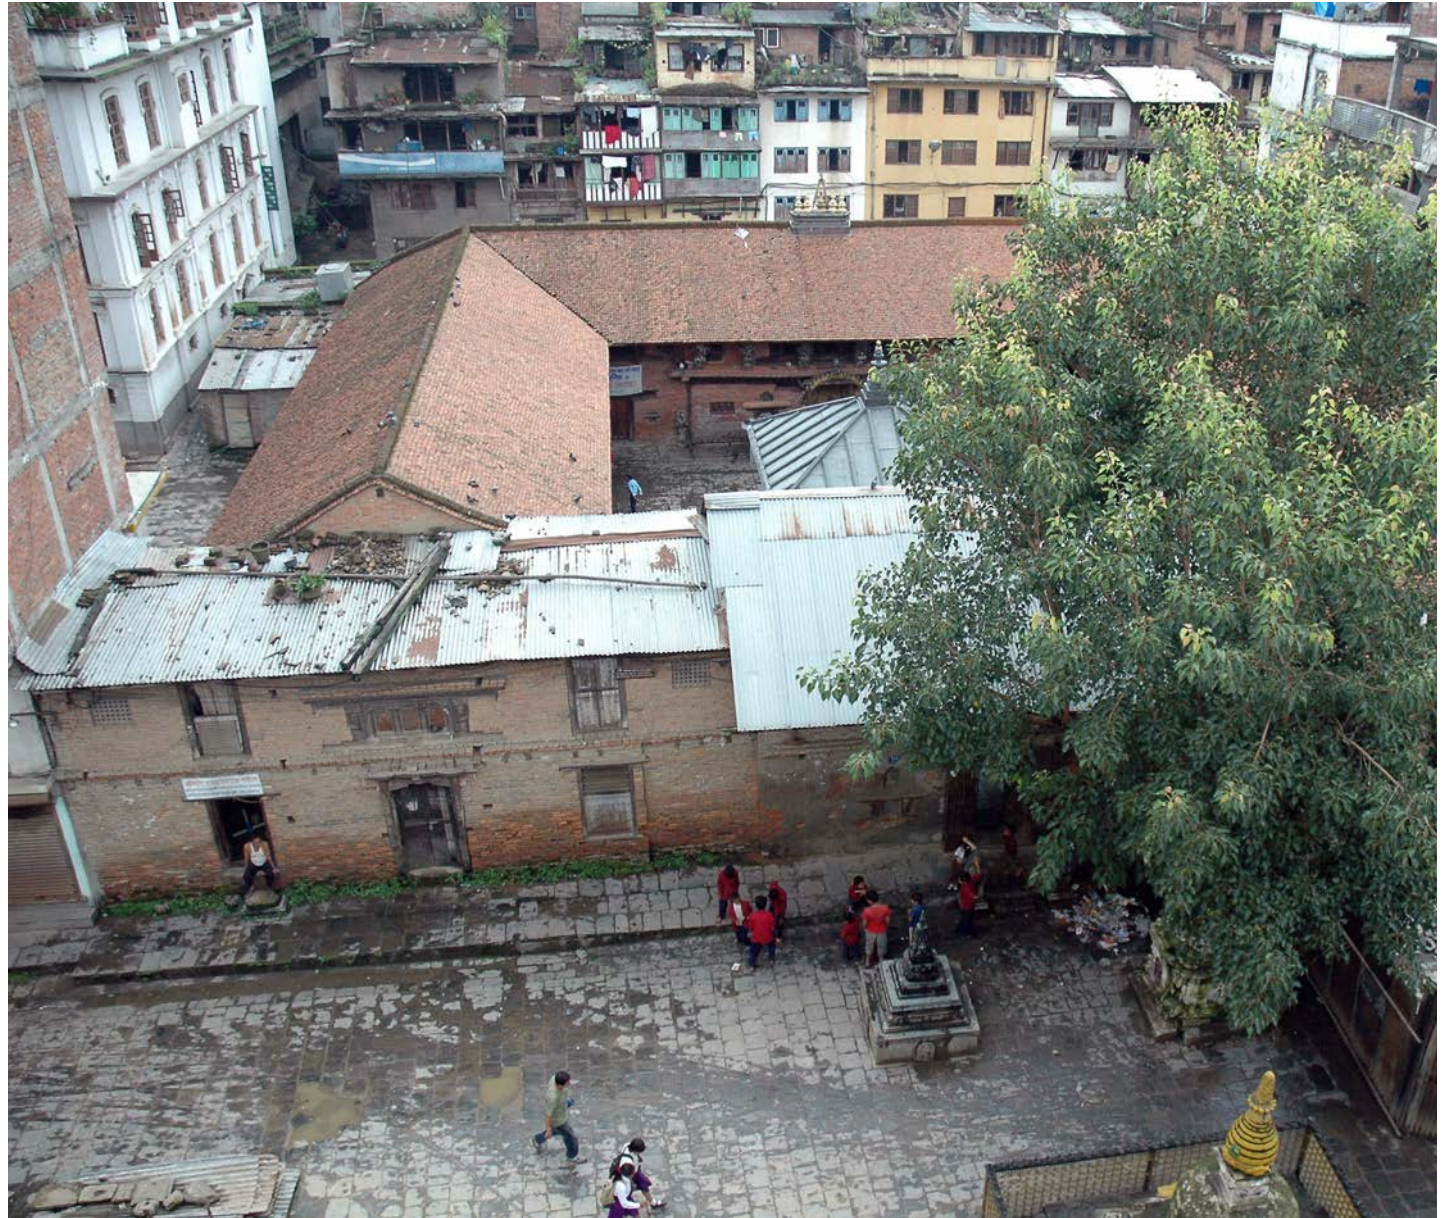
Itumbaha East wing | 2006
Dilapidated condition of the east facade, including the unhistoric corrugated tin roof, windows and doors.

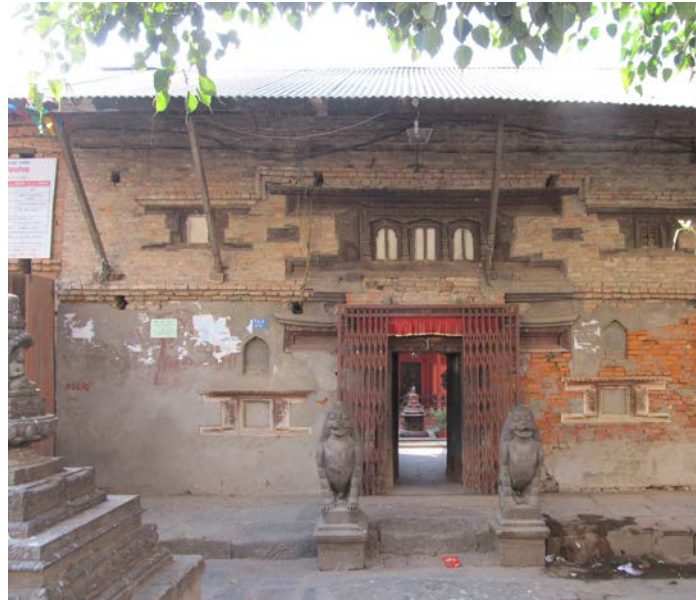
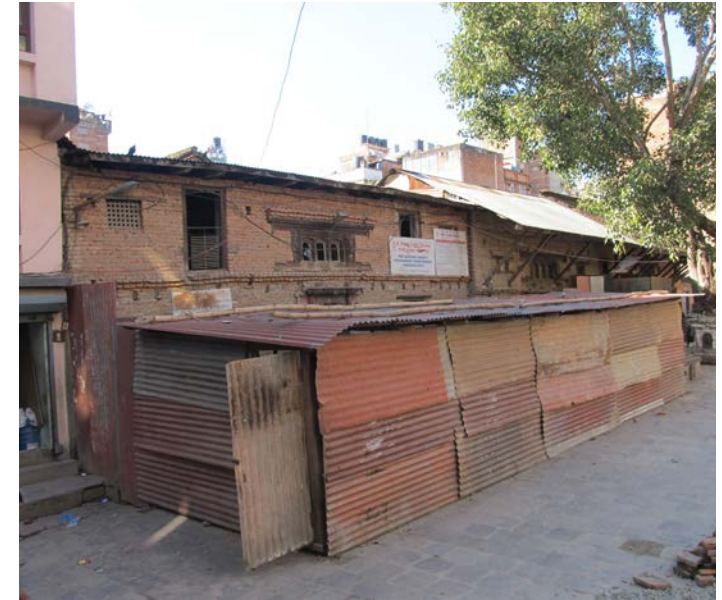
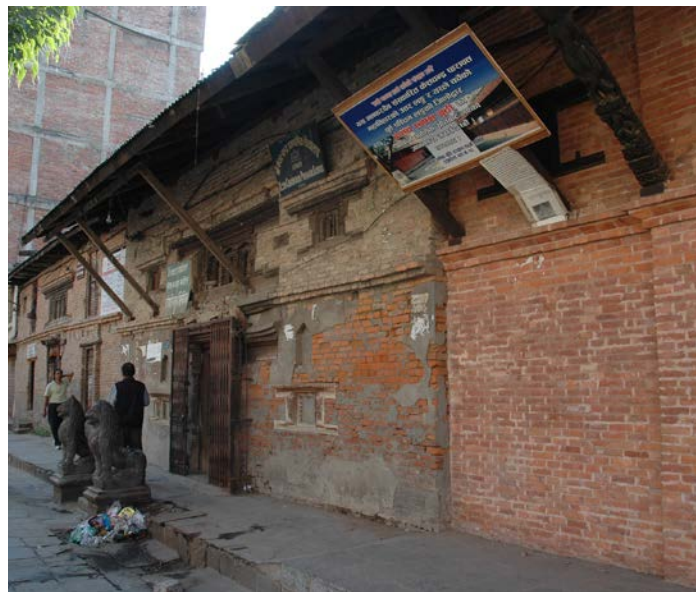
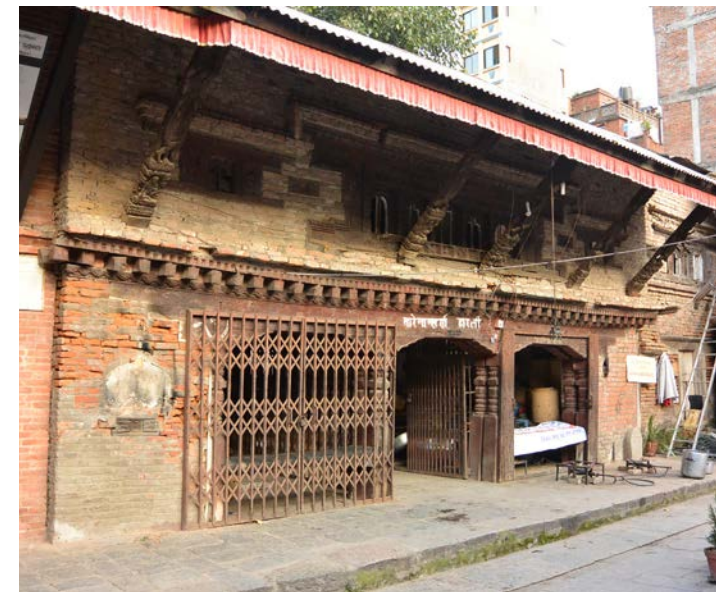
Itumbaha East Wing | March 2015
Existing condition of east and west facade before restoration.

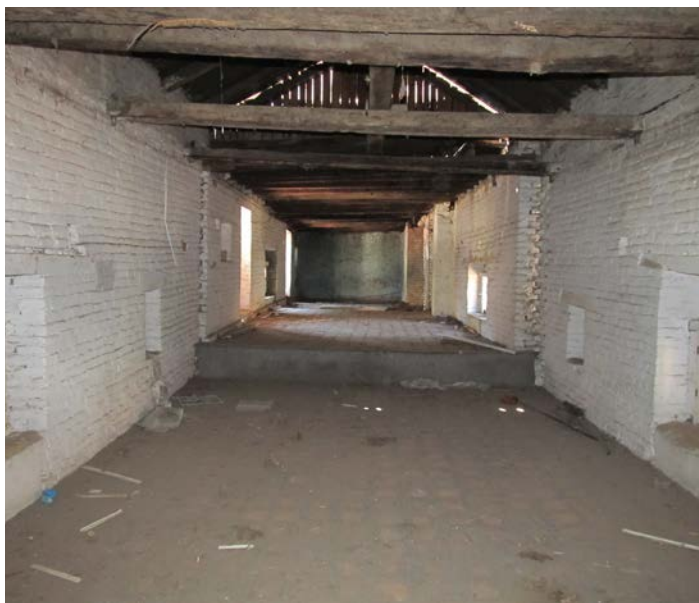
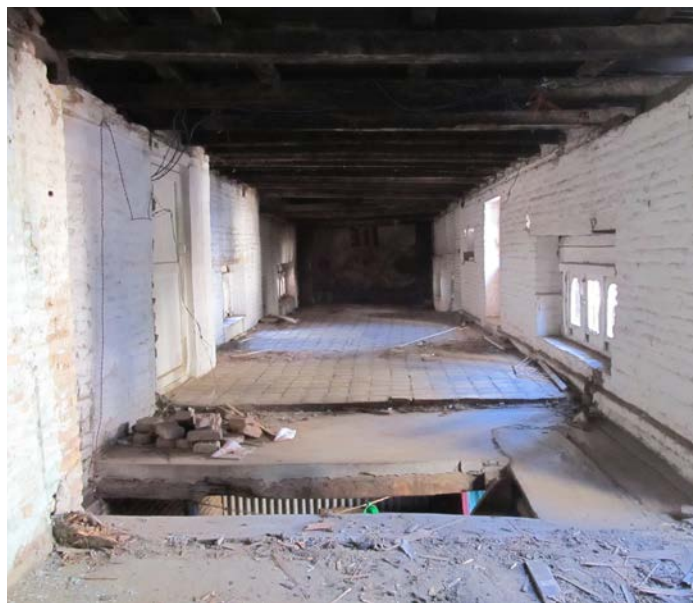
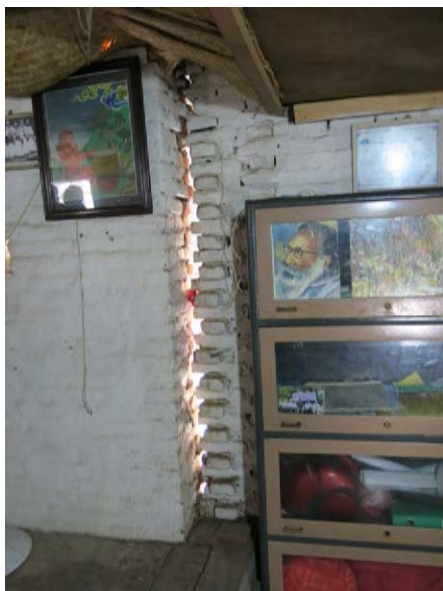
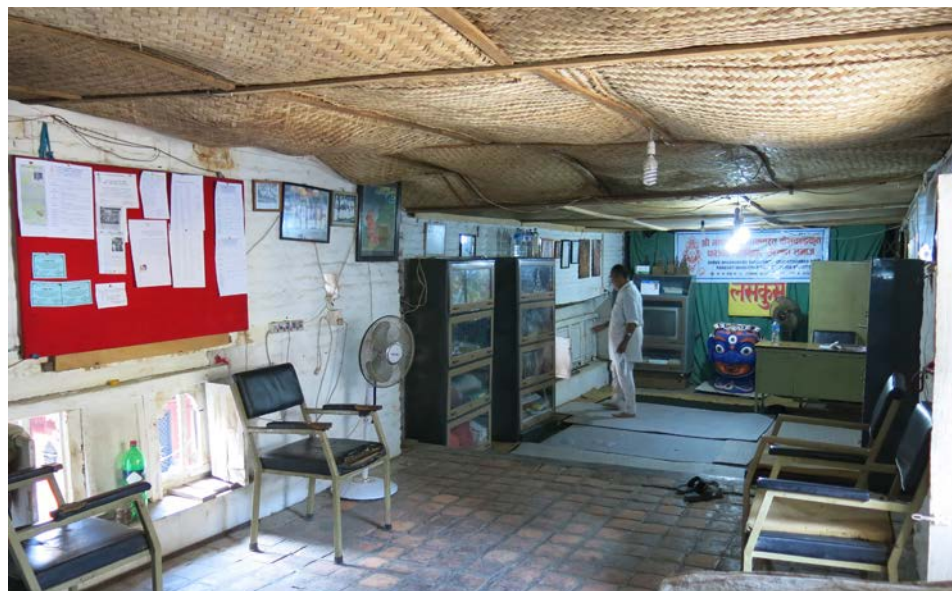
Itumbaha East Wing | March 2015
Existing condition of first floor level interior space
before restoration.

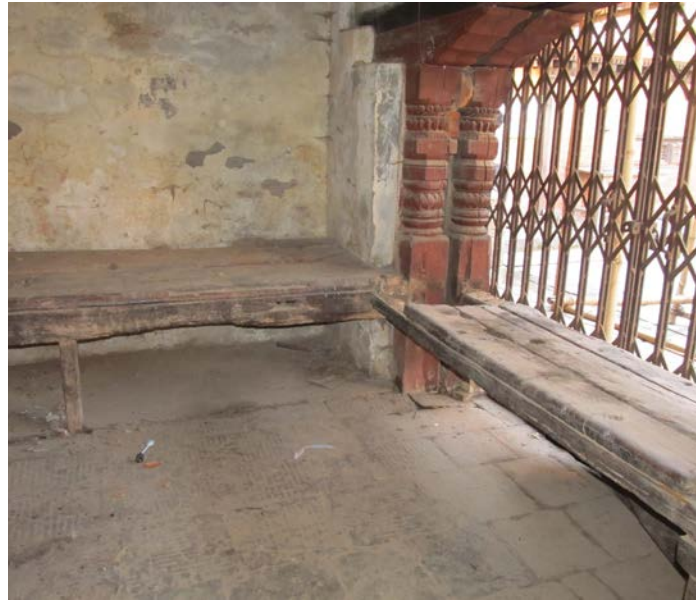
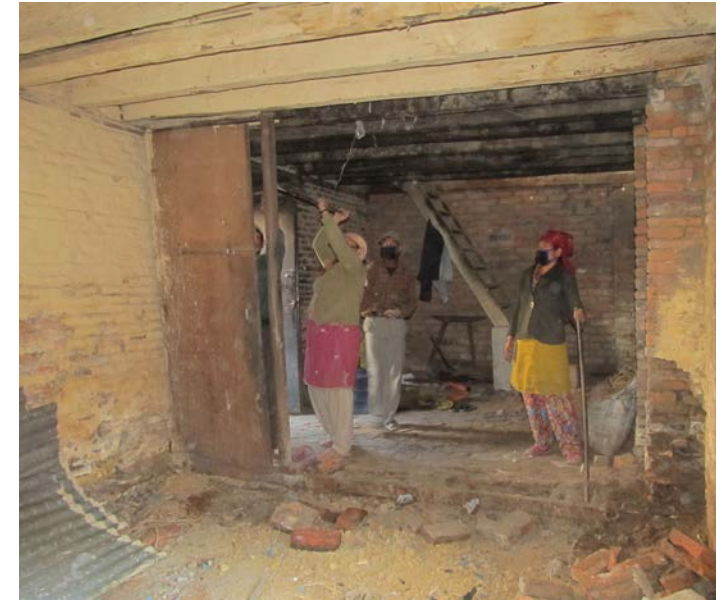
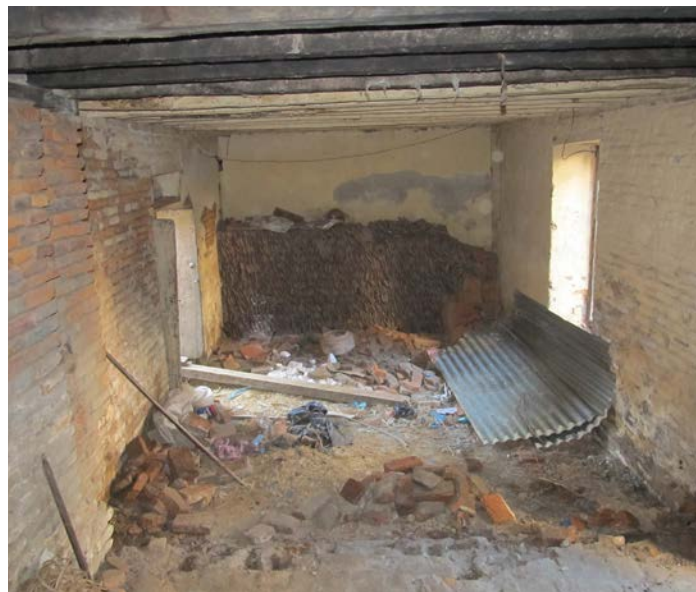
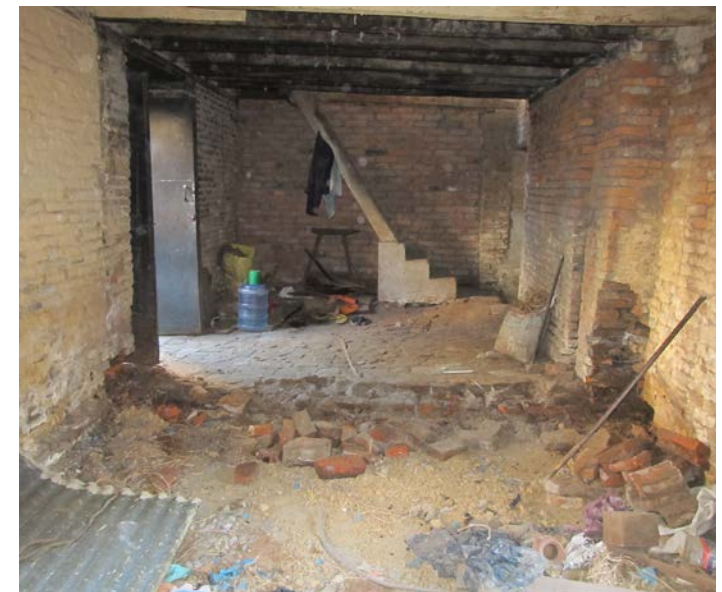
Itumbaha East Wing | March 2015
Existing condition of ground floor interior space
level before restoration.

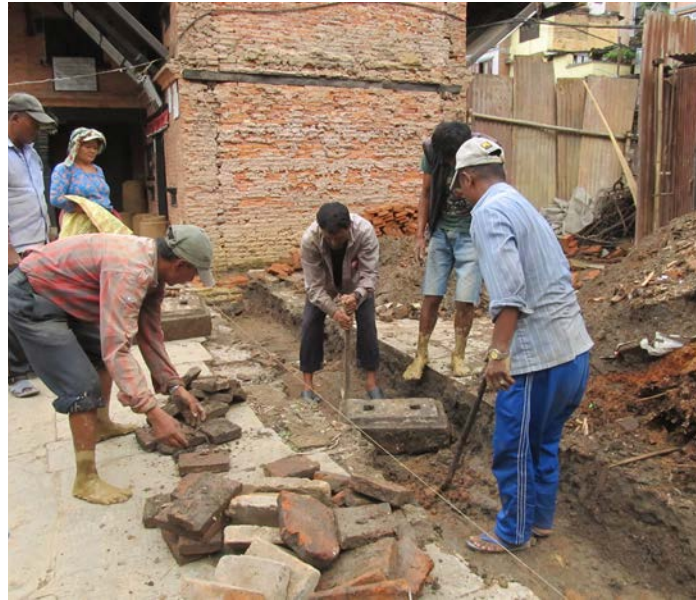
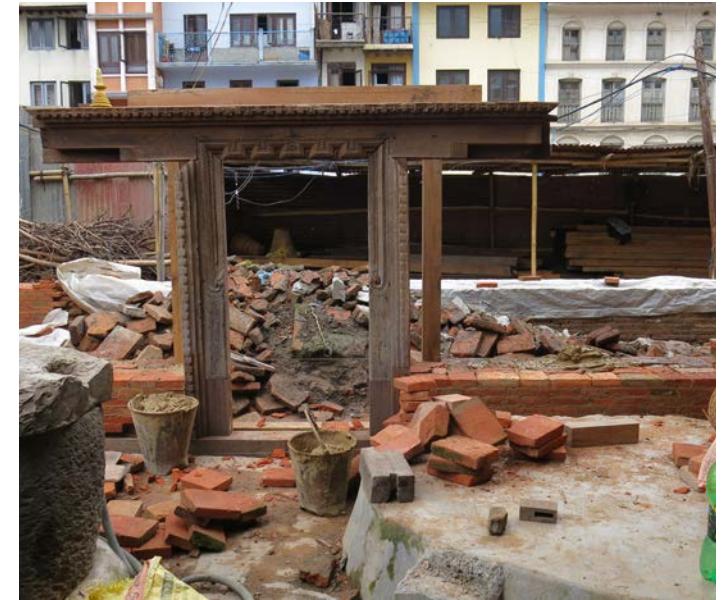
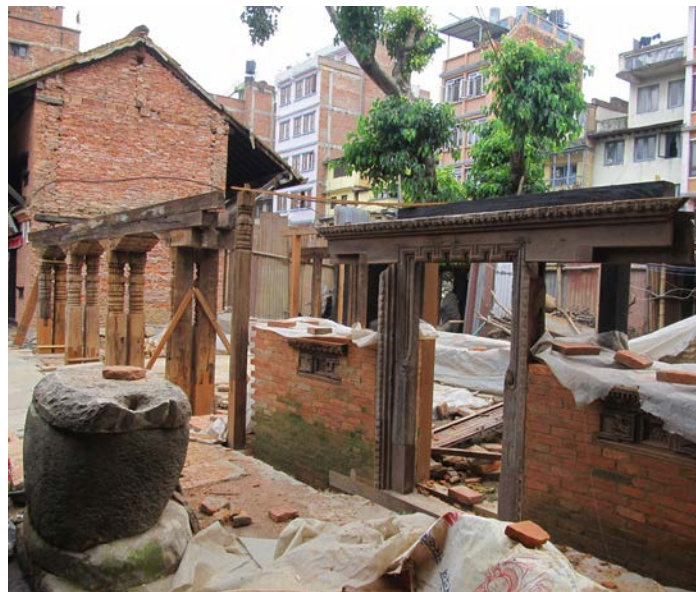
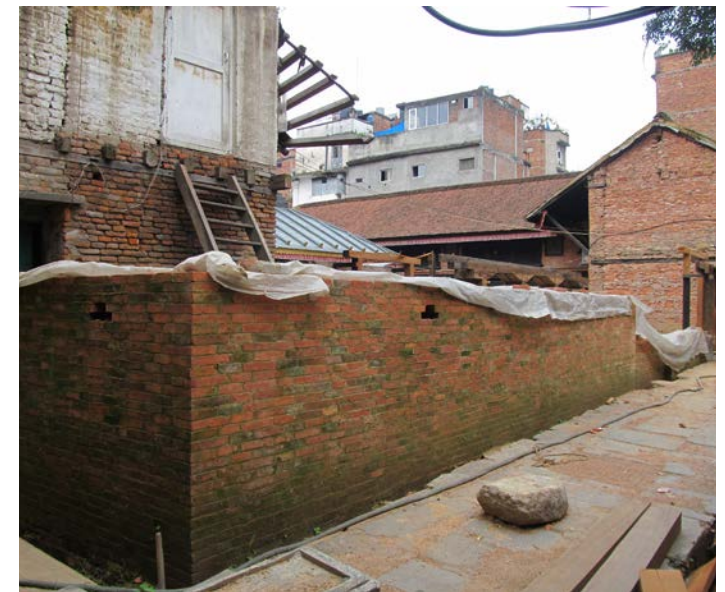
Itumbaha East Wing | August 2015
Existing foundation was assessed and found to be in good condition. Repaired columns erected and building of traditional *ma-apa* brick wall in yellow mud mortar has started.

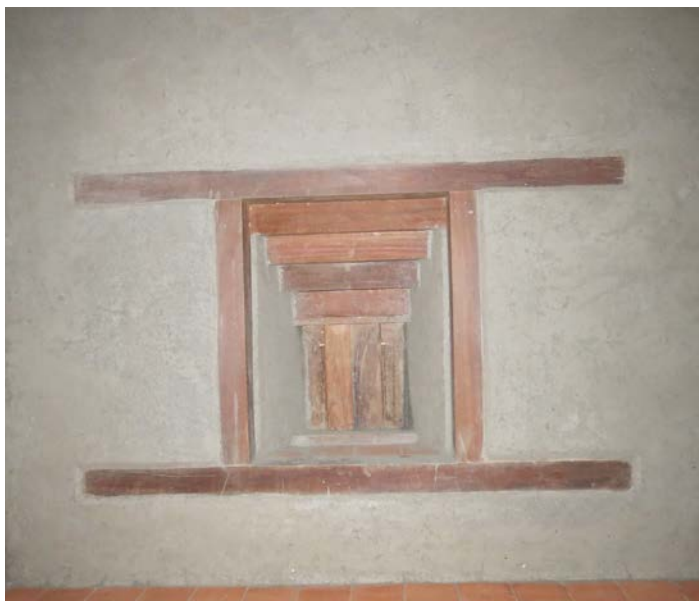
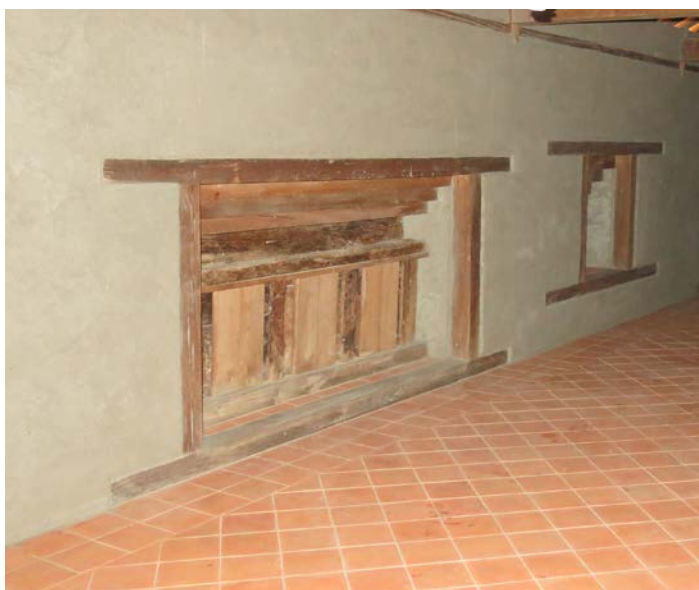
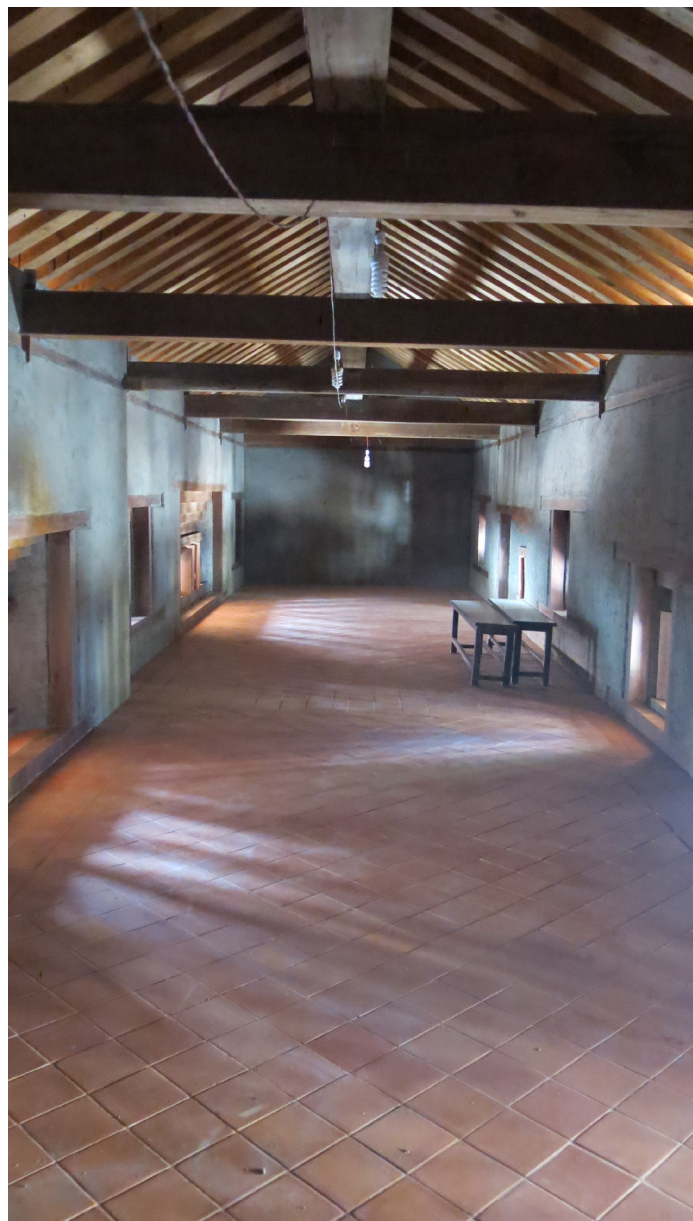
Itumbaha East Wing | Sept, 2017
Laying of new terracotta floor tiles in lime surkhi mortar has been completed in the first floor. All the historical windows are fitted with new inner frames as the original ones were damaged beyond repair. Mud plaster has been applied on the walls.
