THE RESTORATION OF
ITUM BAH
FINAL REPORT | OCTOBER 2017

SUBMITTED TO ORIENTAL CULTURAL HERITAGE SITES PROTECTION ALLIANCE, FRANCE

IMPLEMENTED BY THE KATHMANDU VALLEY PRESERVATION TRUST

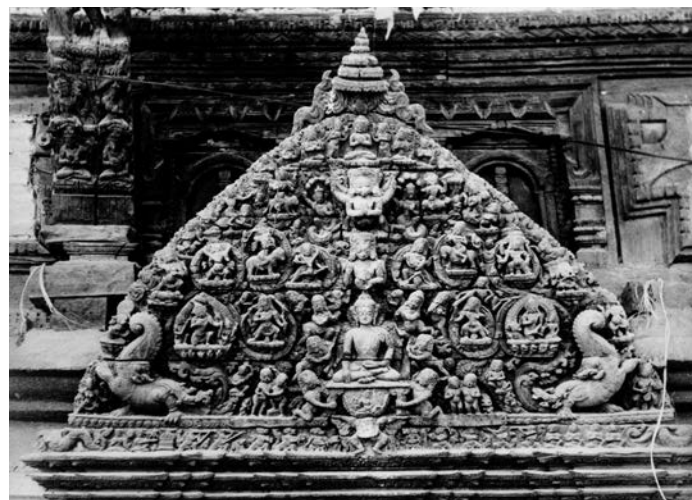
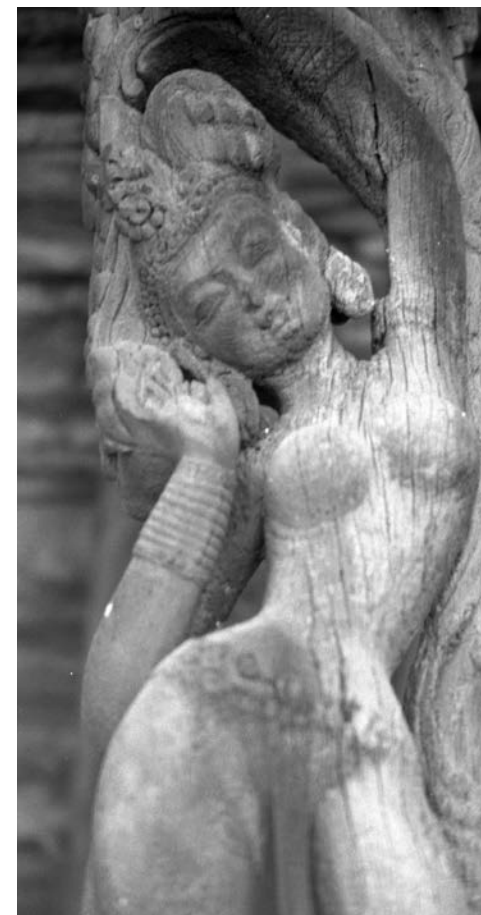
Top
Roof Struts of Itumbaha
One of the three 14th century yaksini struts which was stolen from the monastery in the mid-1980s.
Left
Main Door Tympanum of Itumbaha | August 1999
The "Victory over Mara" tympanum (*toran*), installed in 1627
Photograph S. Klimek

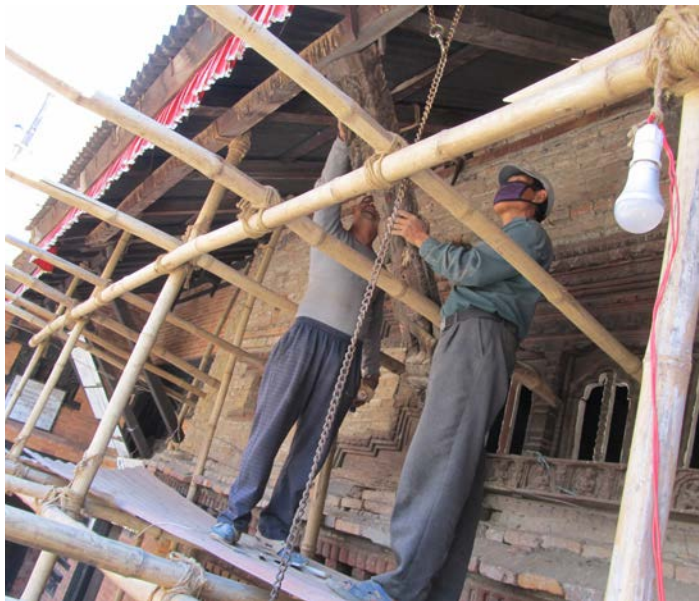
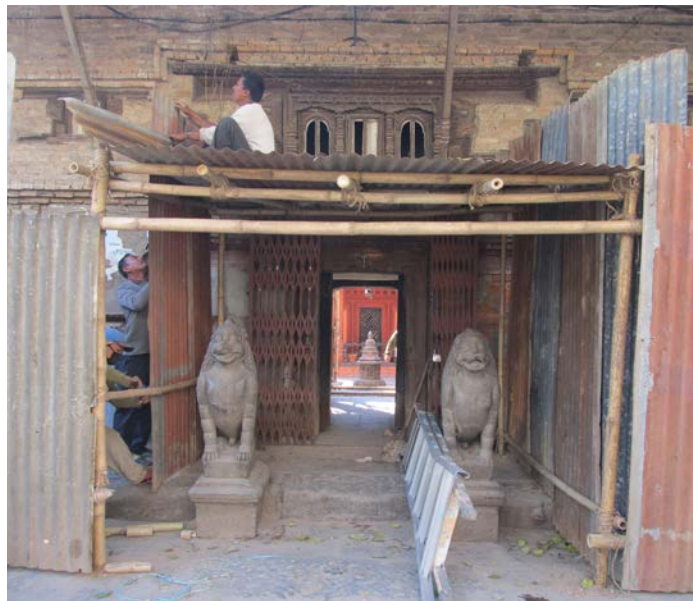
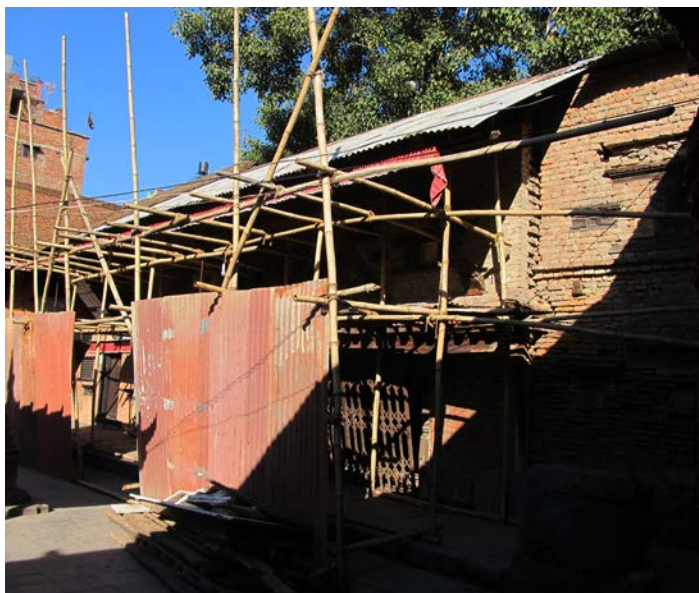
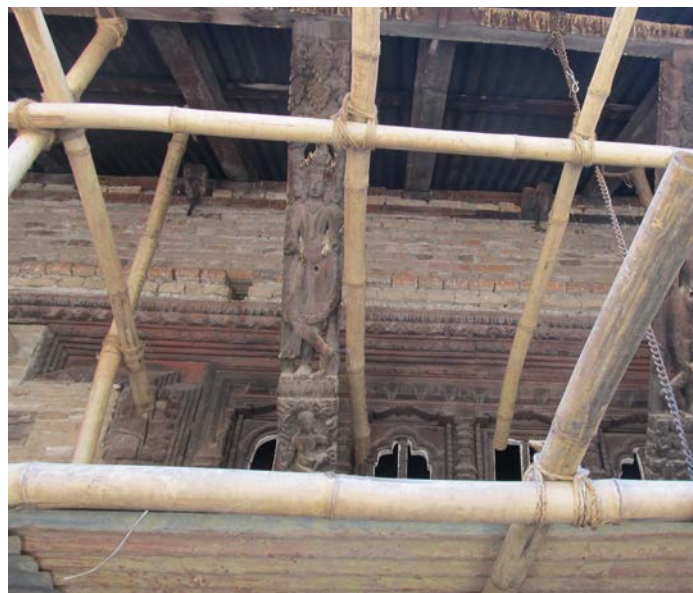
Itumbaha East Wing | March 2015
Installation of fencing and constructing of
scaffolding for dismantling the existing structure.

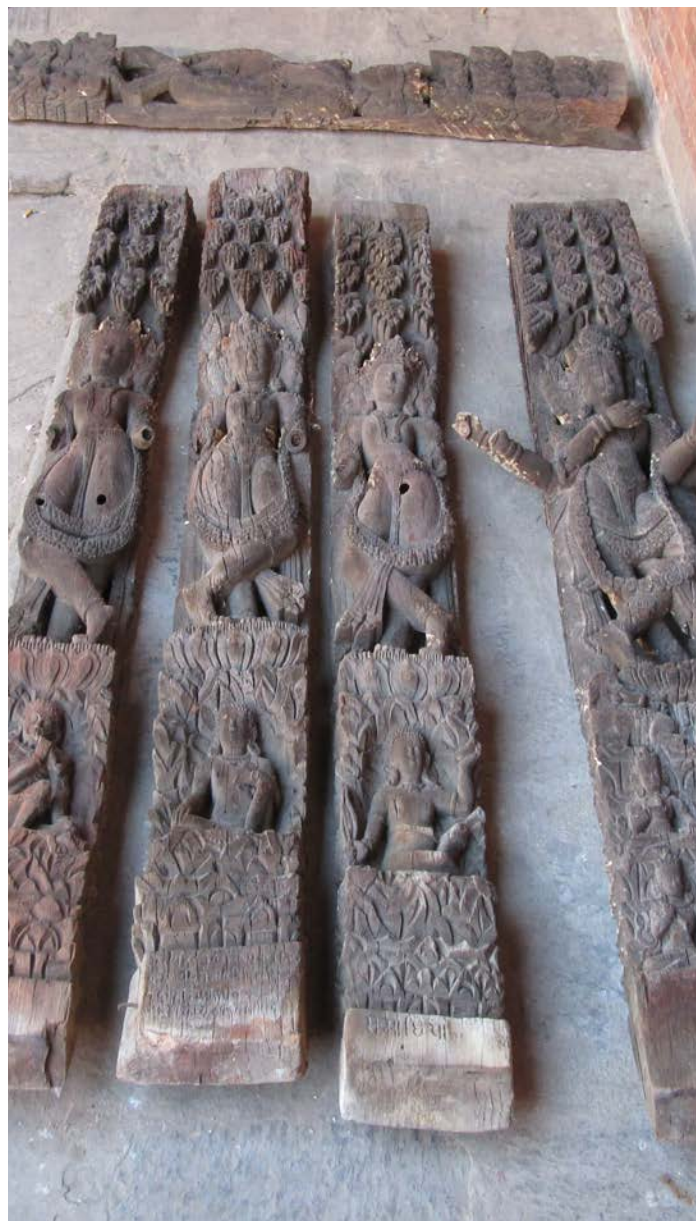
Itumbaha East Wing | March 2015
Historic roof struts were taken off carefully and stored.

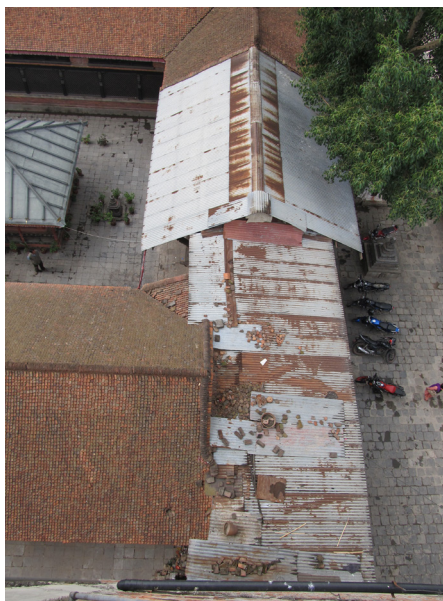
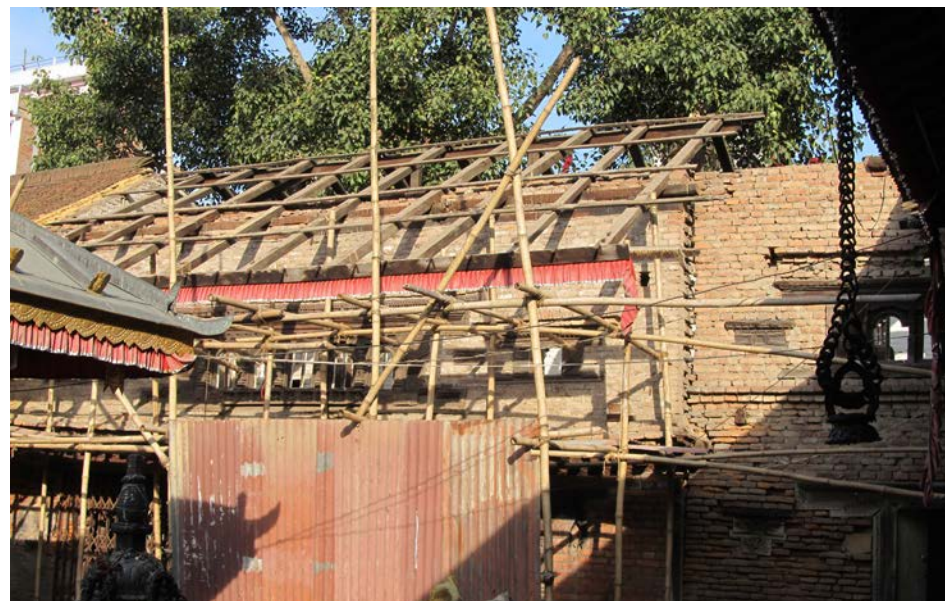
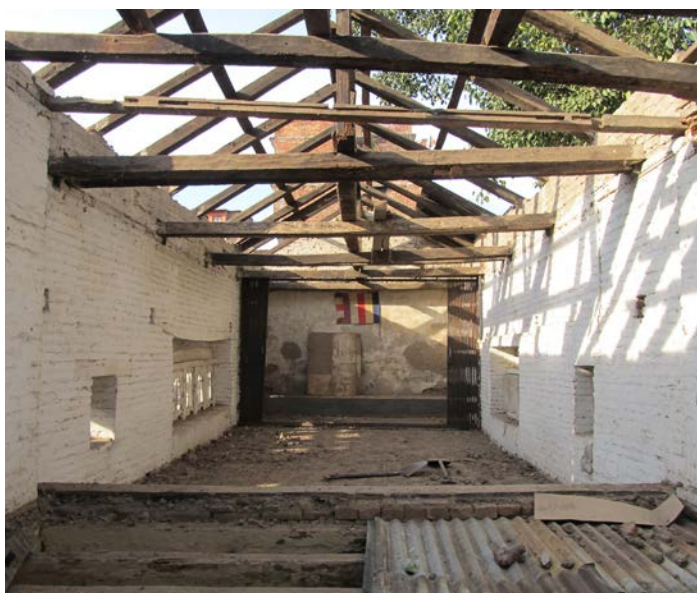
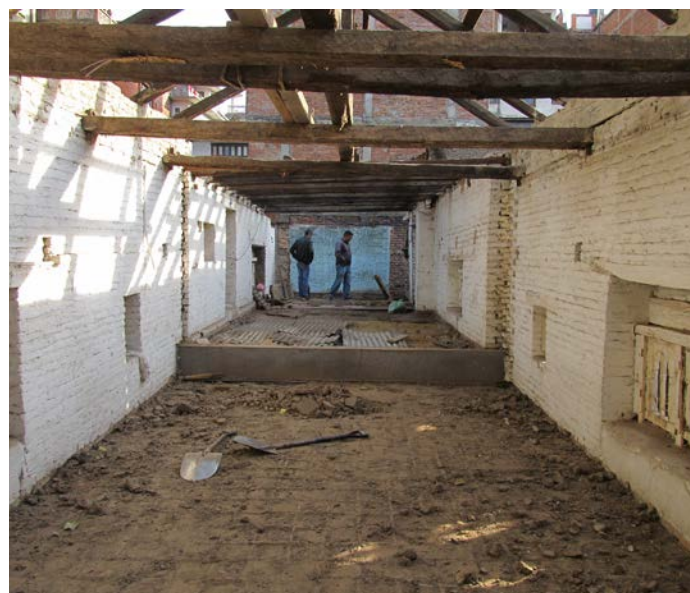
Itumbaha East Wing | March 2015
Existing corrugated tin sheet roof dismantled.

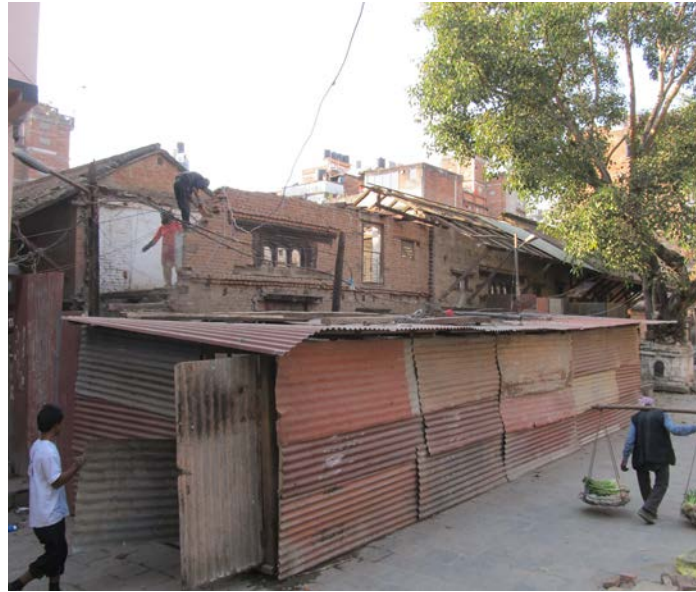
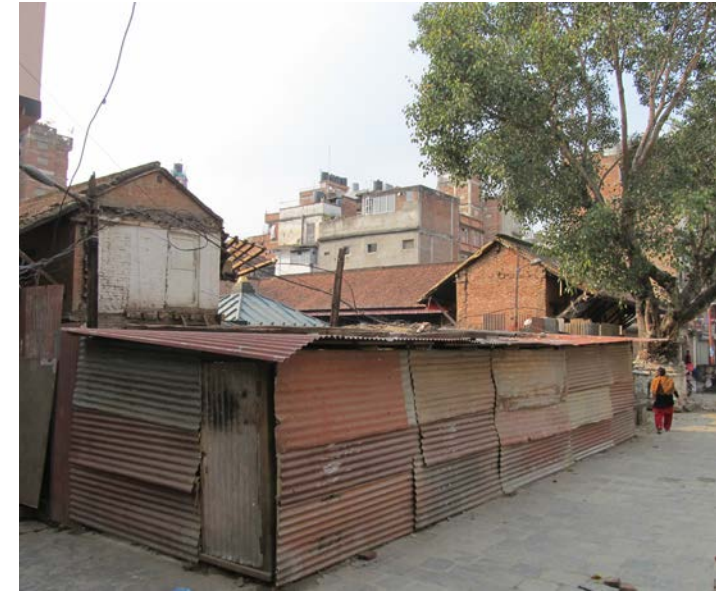
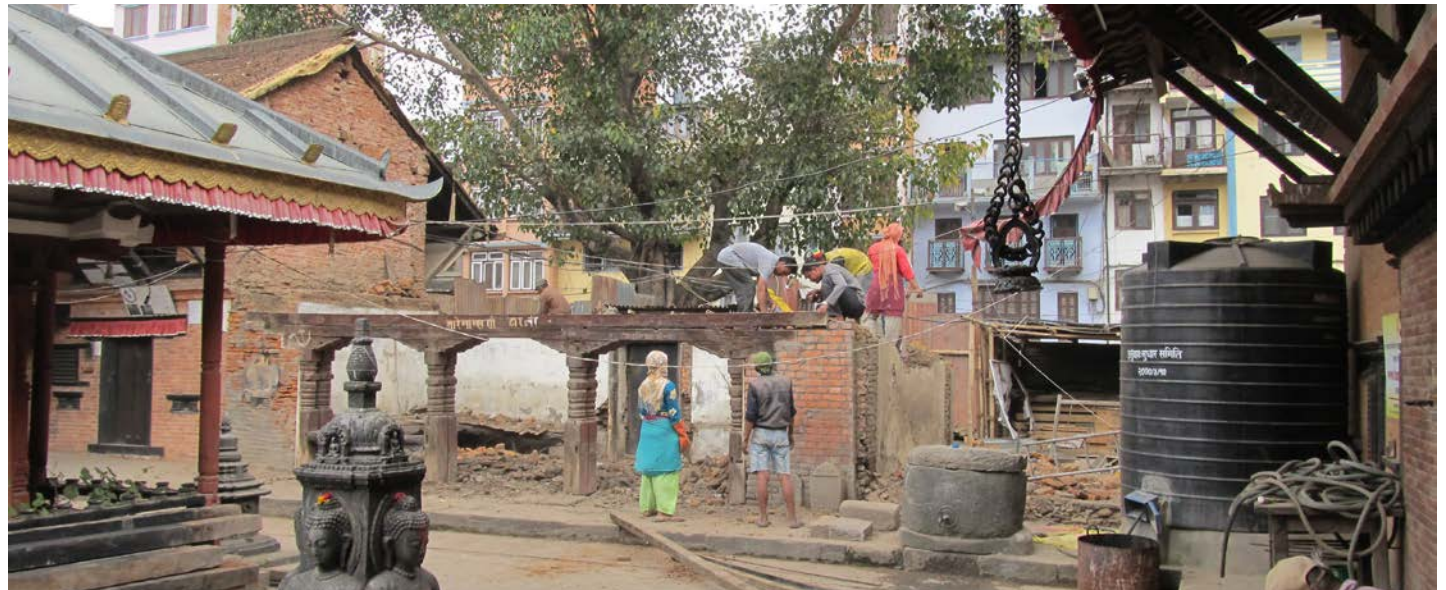
Itumbaha East Wing | March 2015
Views of Itumbaha east wing from east and
courtyard during dismantling.

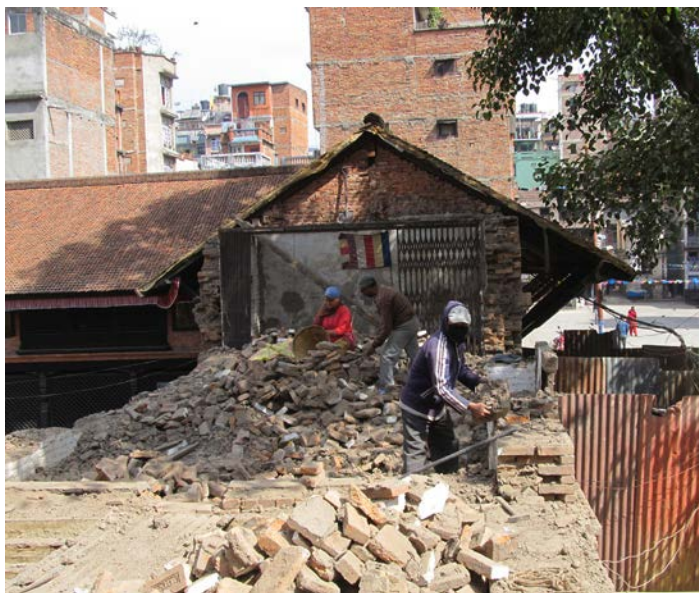
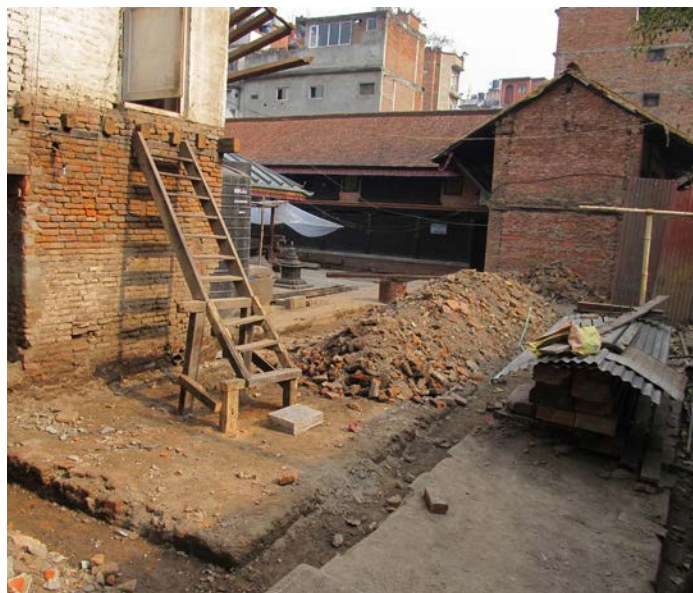
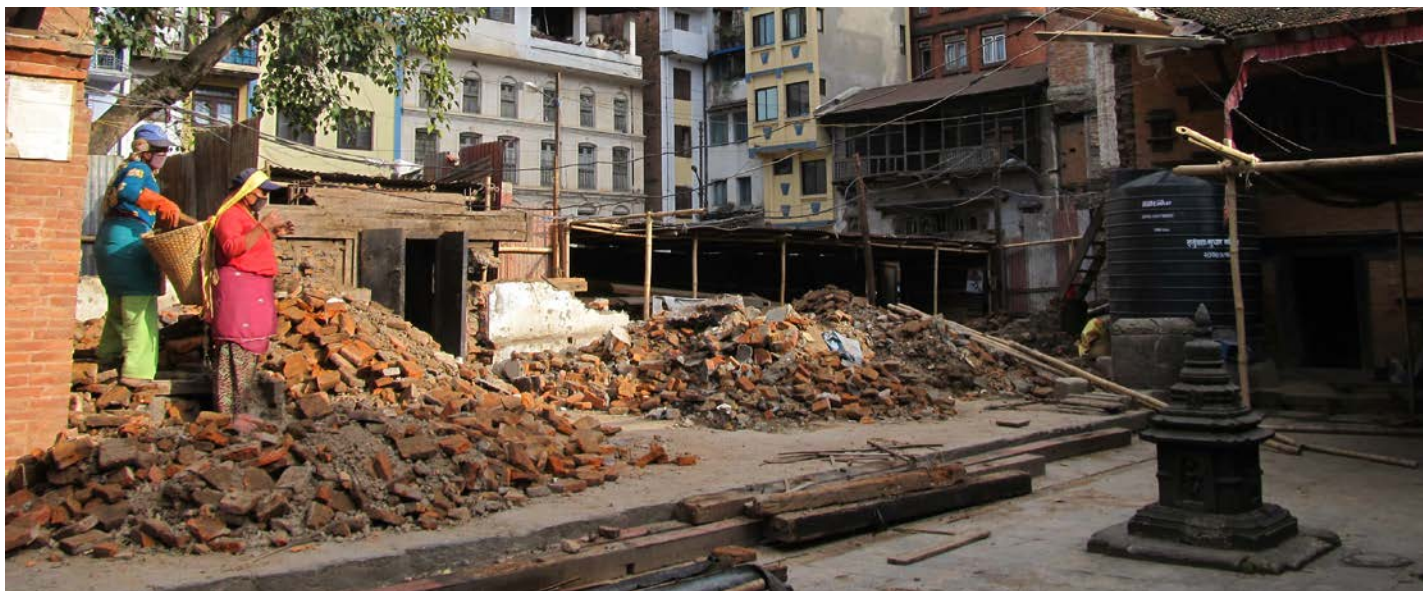
Itumbaha East Wing | March 2015
Views of Itumbaha east wing from south and courtyard during dismantling process.

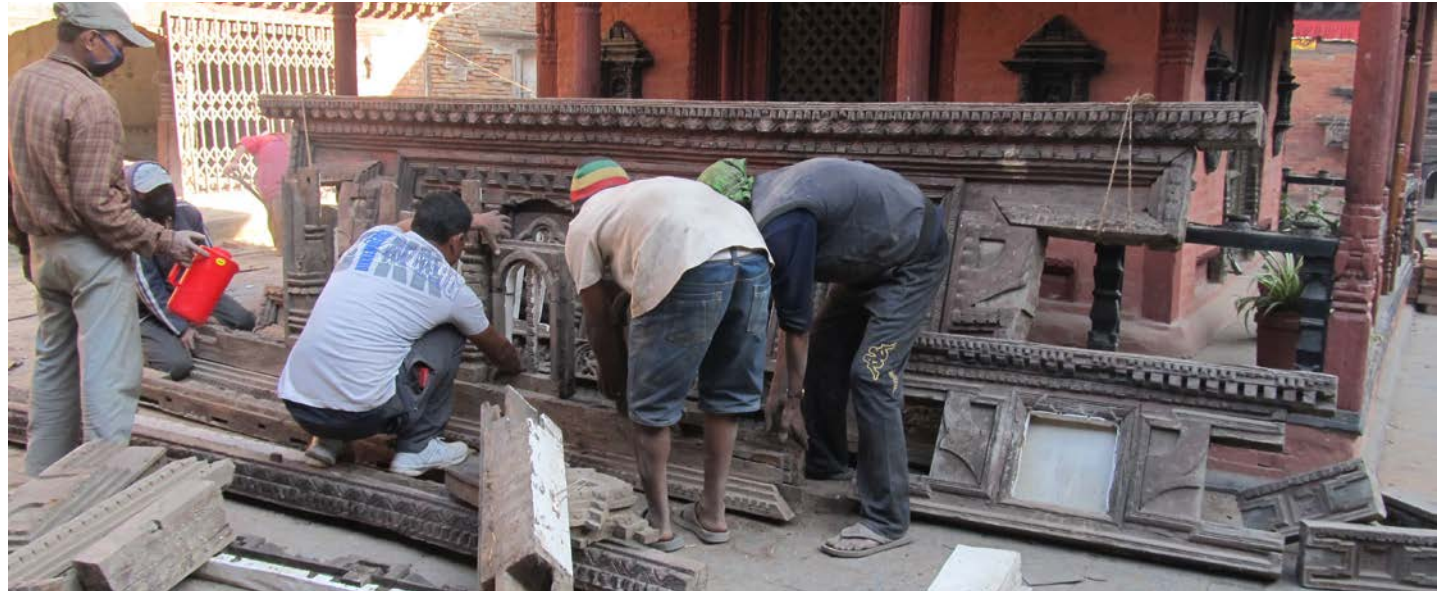
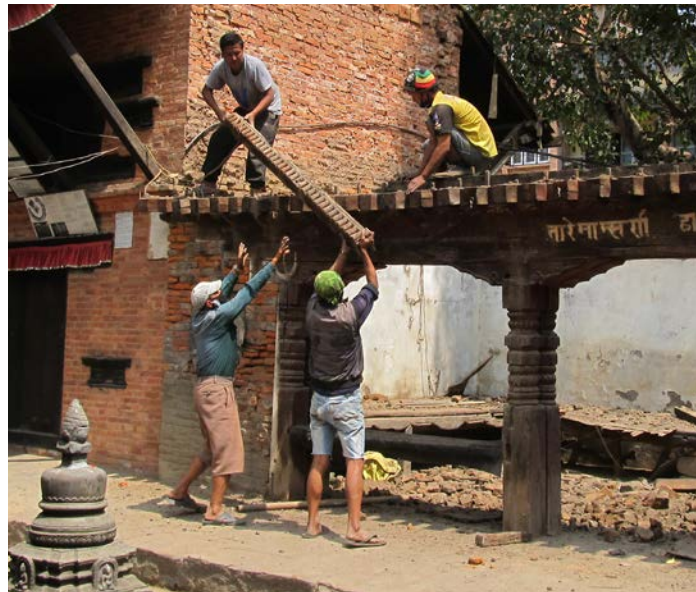
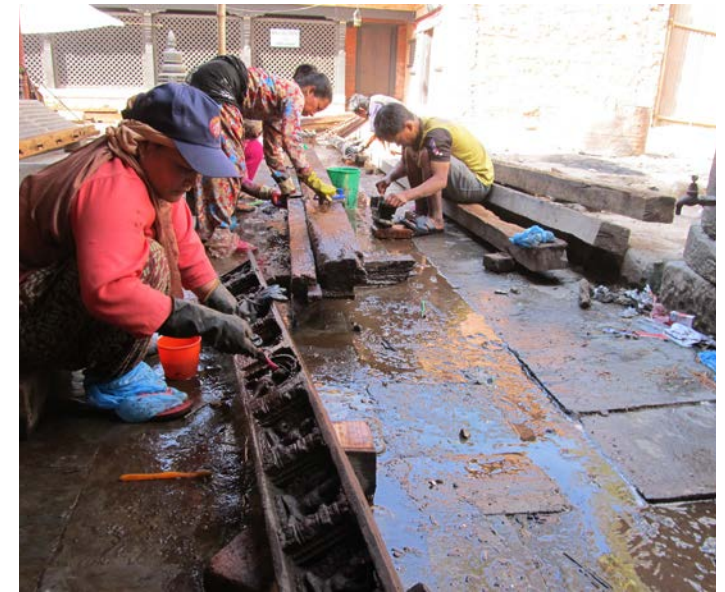
Itumbaha East Wing | April 2015
All timber elements are carefully removed and cleaned with plain water and caustic soda to remove dirt and unhistoric paints applied in the past.

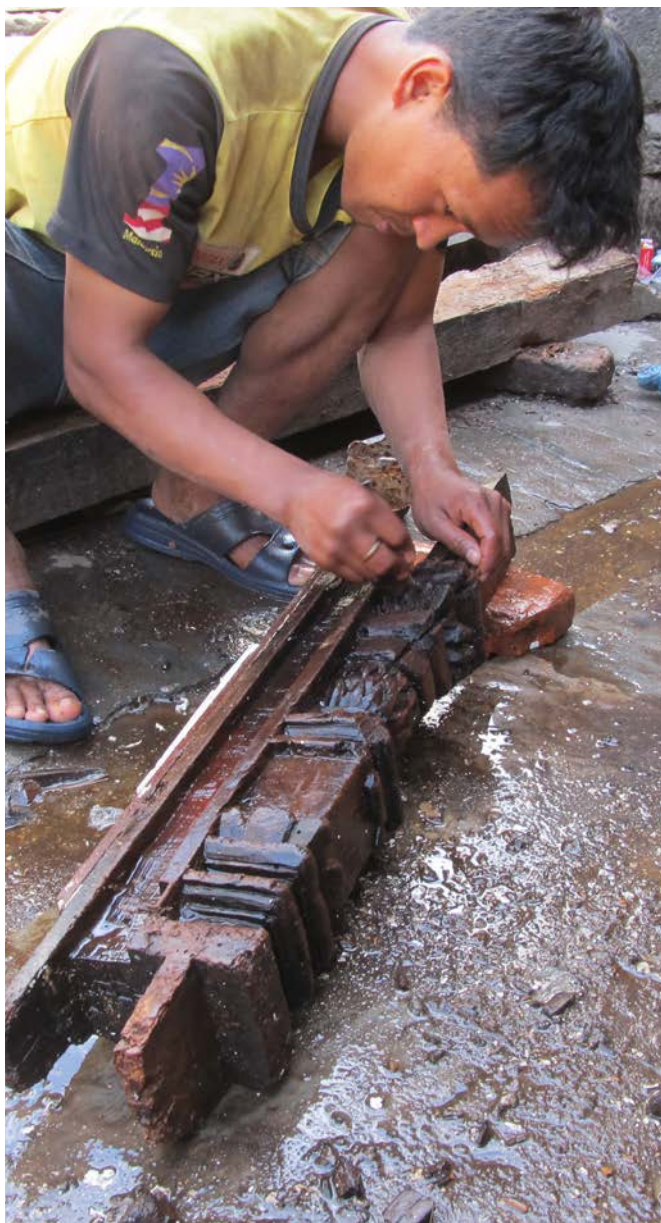
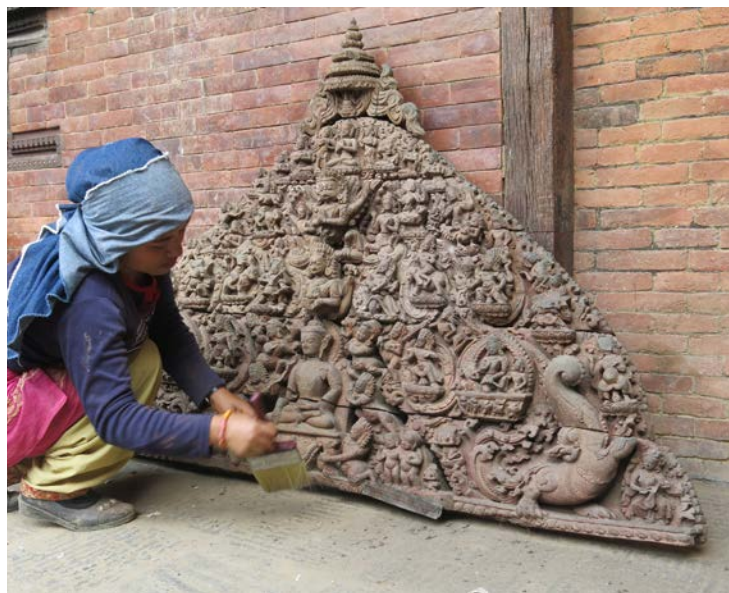
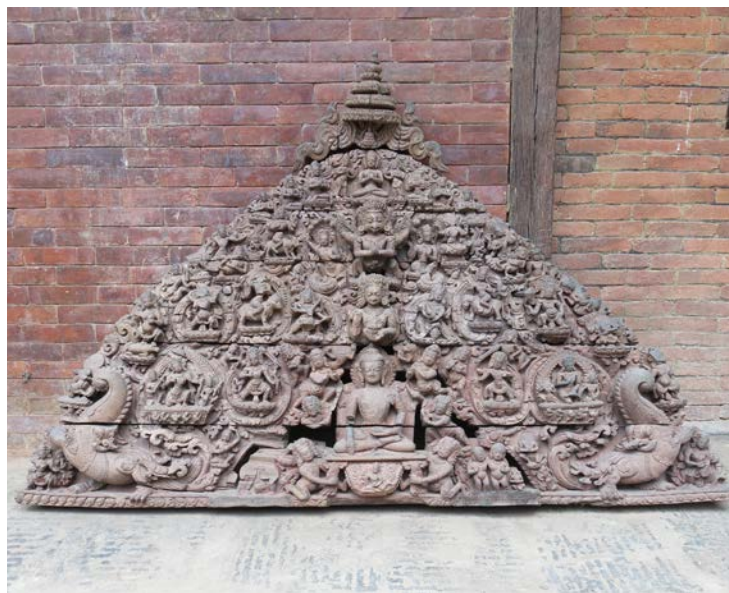
Itumbaha East Wing | April 2015, Aug 2016
The “victory over Mara” tympanum originally installed above the main entrance on east facade is being cleaned with dry brush. Due to security reason this tympanum has not been reinstall in its original location and is stored inside the monastery,

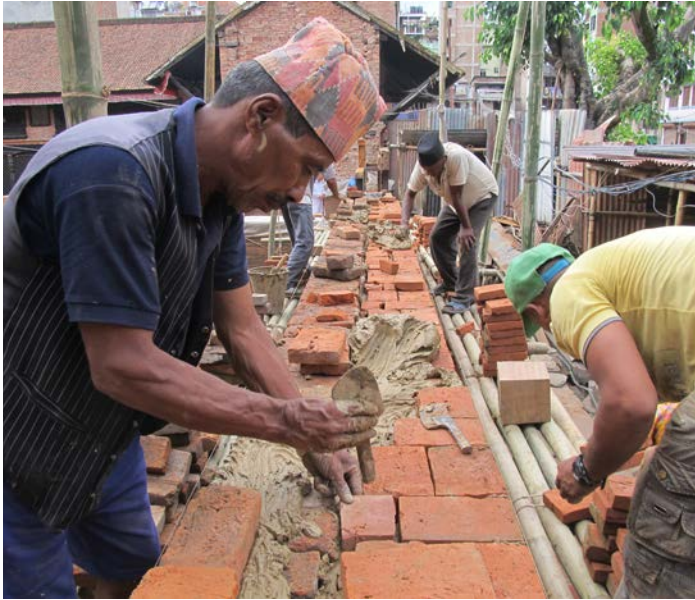
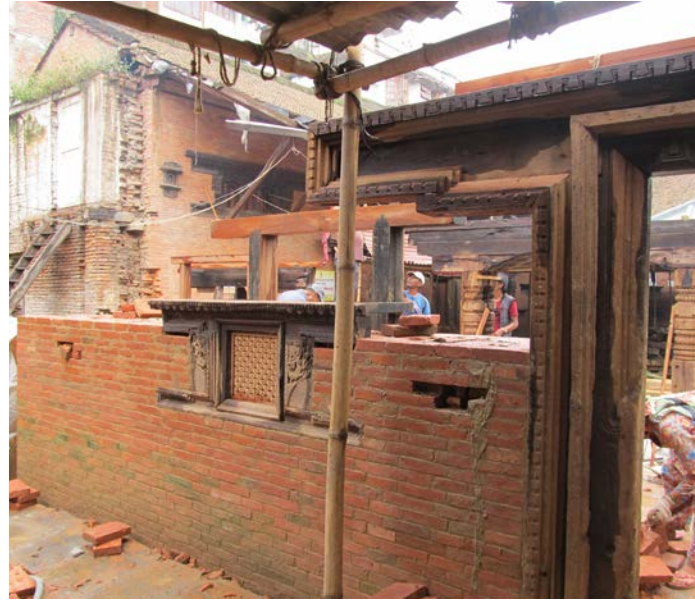
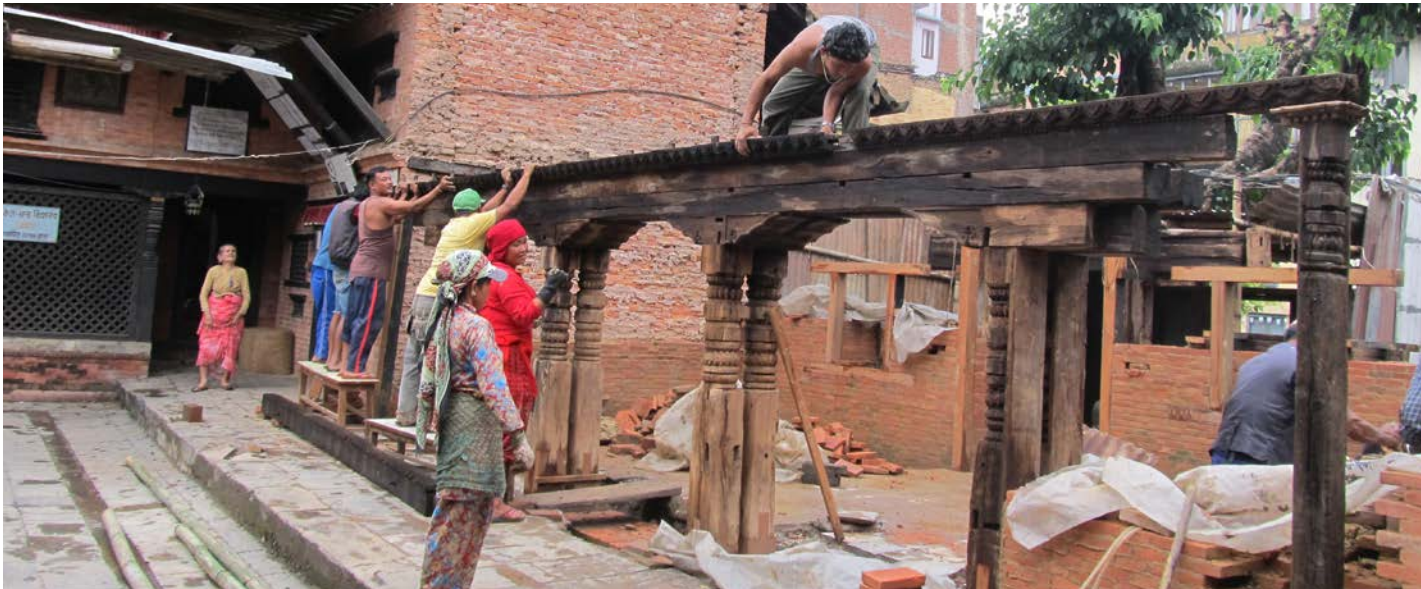
Itumbaha East Wing | September 2015
Masons rebuilding ground floor masonry wall in traditional ma-apa brick with yellow mud mortar Ongoing rebuilding of masonry wall and reinstallation of the repaired/restored wooden elements in their existing locations.

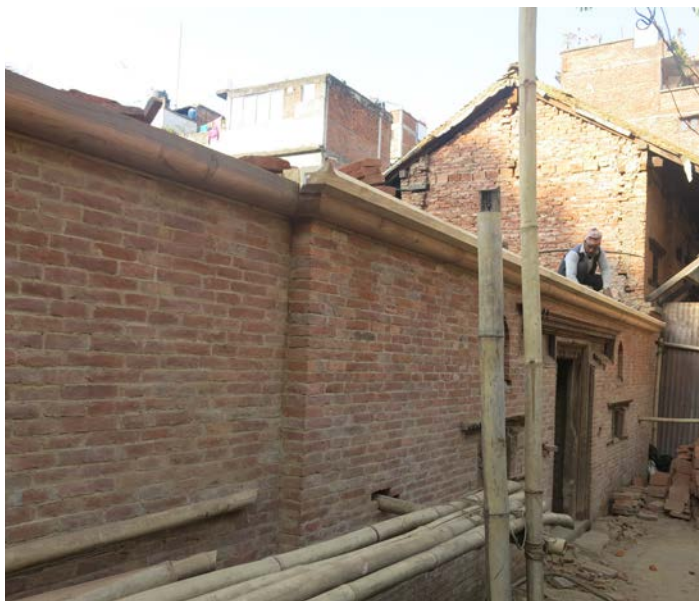
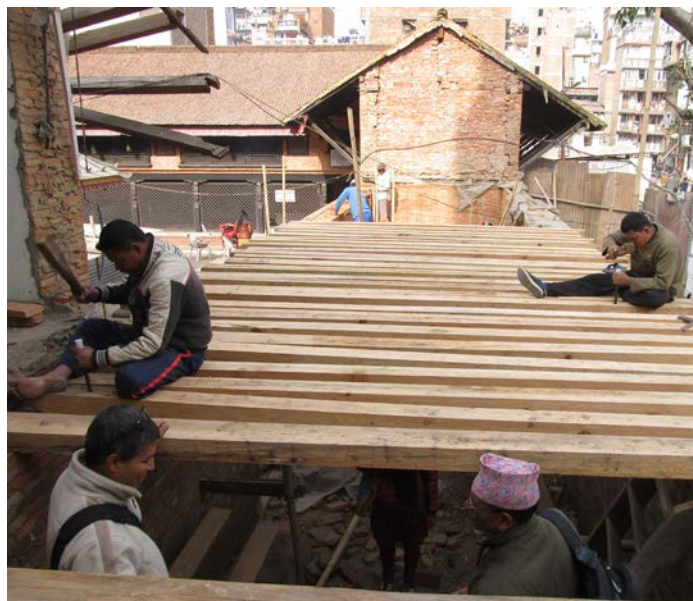
Itumbaha East Wing | Sept & Dec 2015
Carpenters installing the first floor joists including new timber cornice on principal facade.

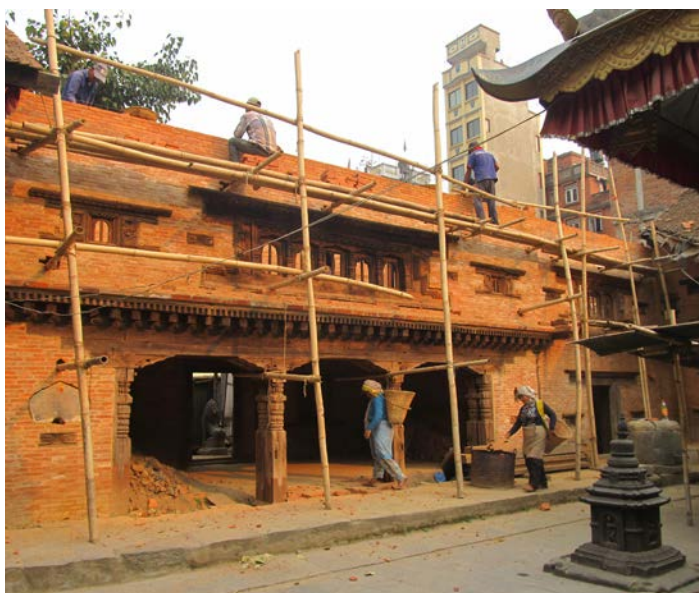
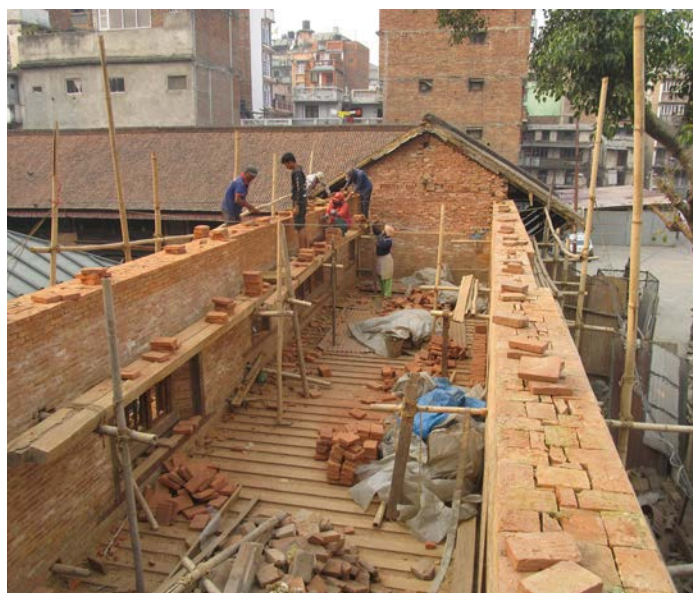
Itumbaha East Wing | January & March 2016
Masons rebuilding first floor masonry wall in traditional *ma-apa* brick with yellow mud mortar after the installation of historical windows, which were repaired, replicated and retrofitted.

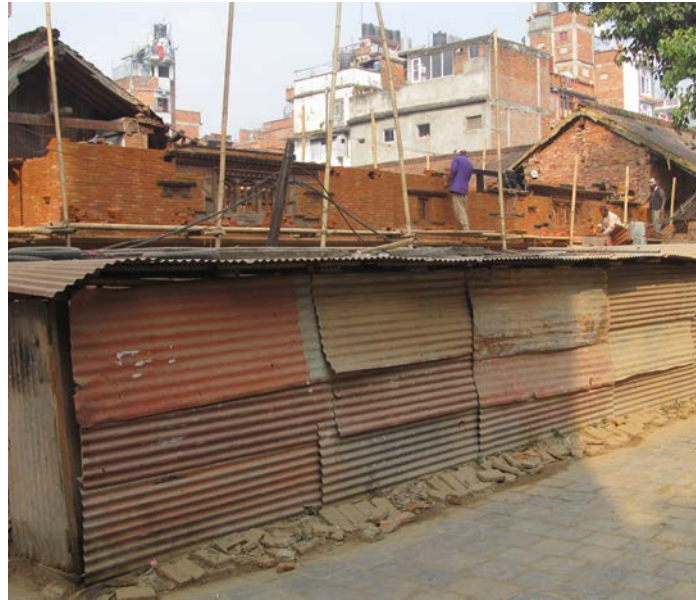
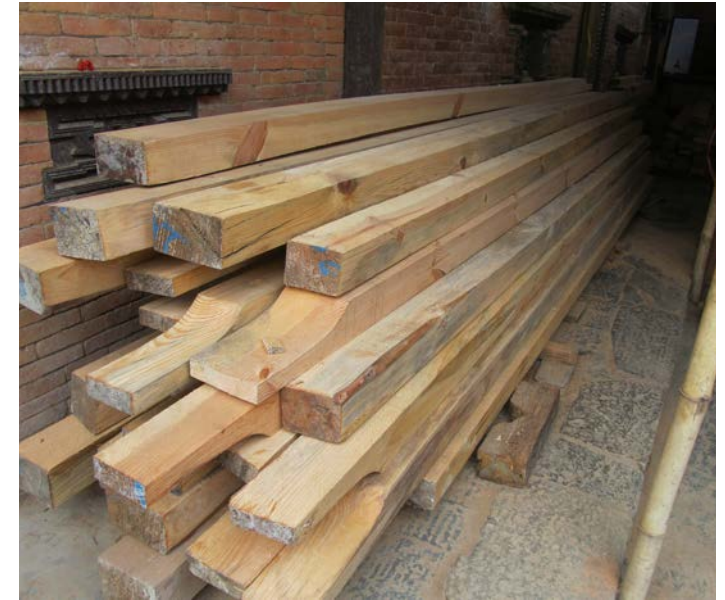
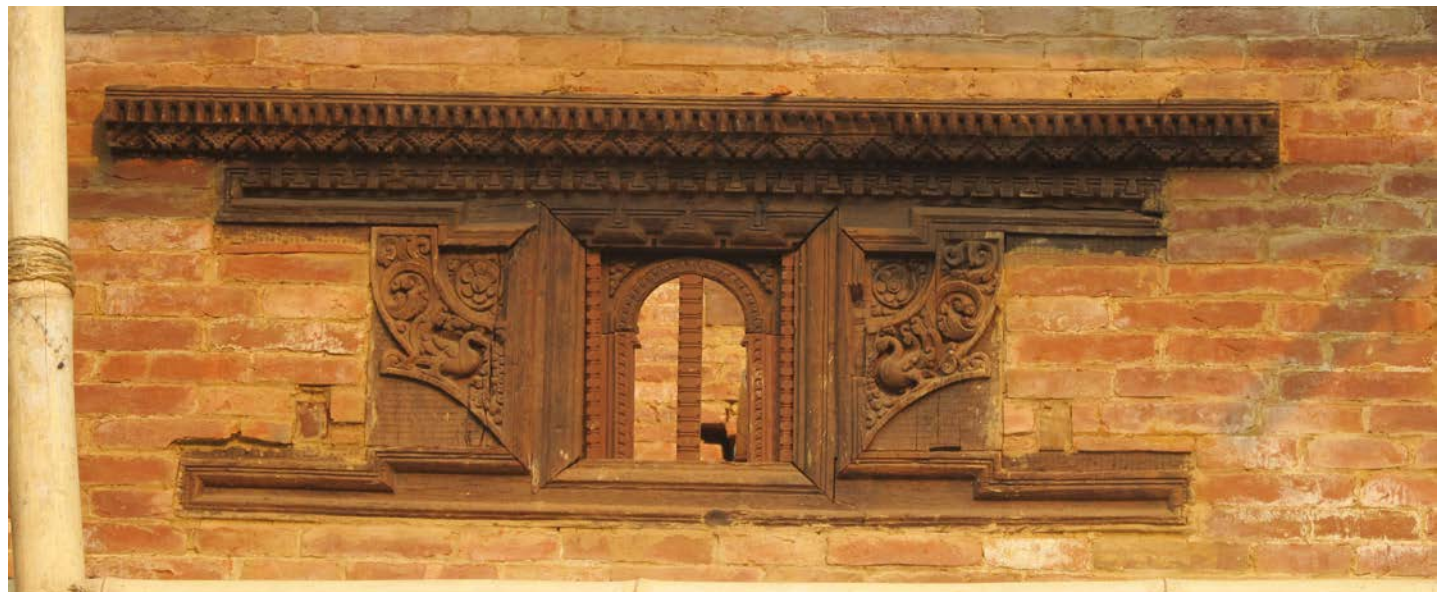
Itumbaha East Wing | Jan & Mar 2016
 Rebuilding of completed up to second floor level.
 New pine rafters prepared by giving adze finishing and sizing and are ready for roof reconstruction.
 Close up view of one of the installed historical blind window.

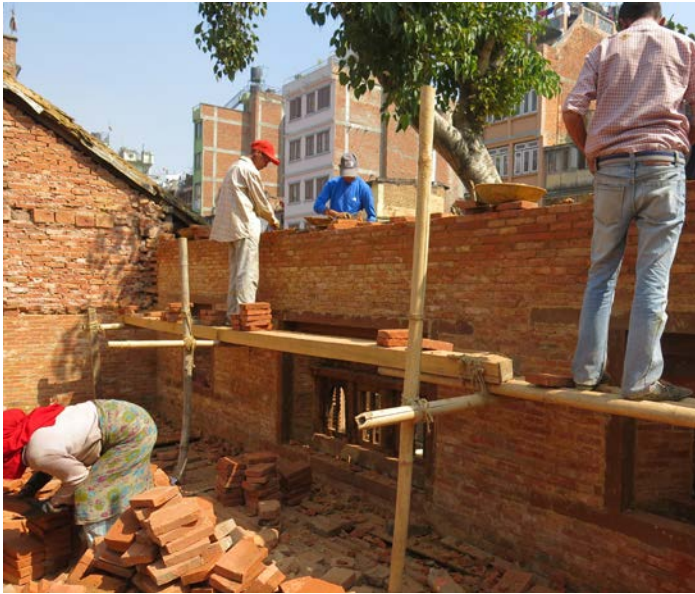
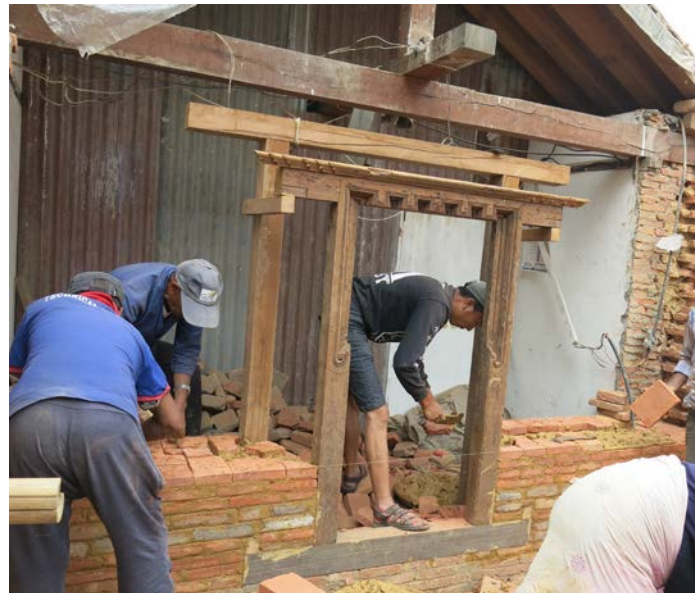
Itumbaha East Wing | Feb & Mar 2016
Masons rebuilding traditional *ma-apa* brick wall in yellow mud mortar on the principal east facade above second floor level. Partition wall is being built in traditional *ma-apa* brick after the installation of inner and outer doorframe in southeast corner roof on first floor level.

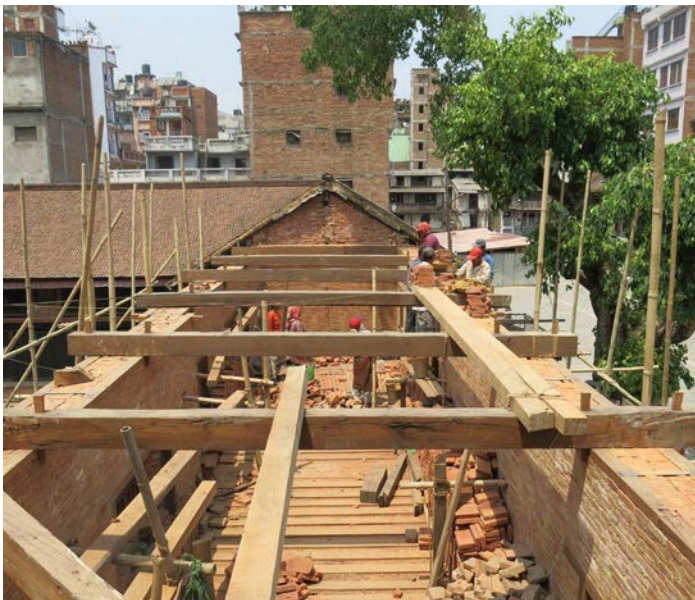
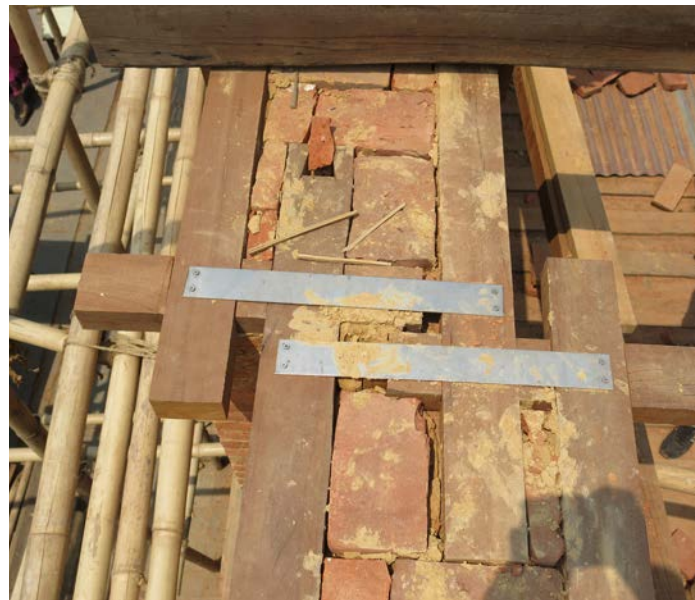
Itumbaha East Wing | April 2016
Installation of *sa/* wood cross beams on attic level completed. Stainless steel plates were installed with screws to tie the inner and outer wall plates.

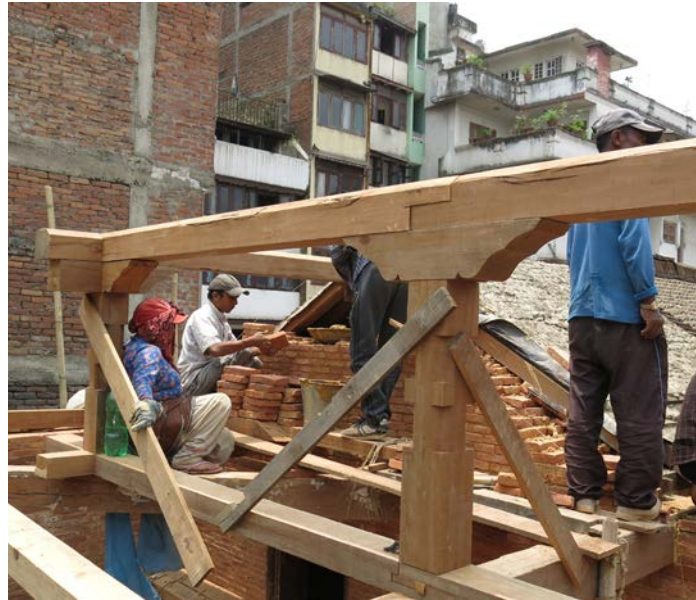
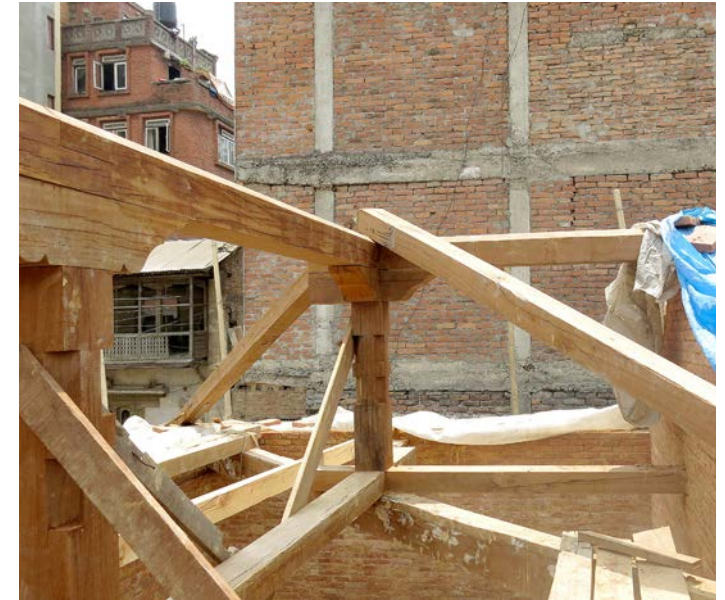
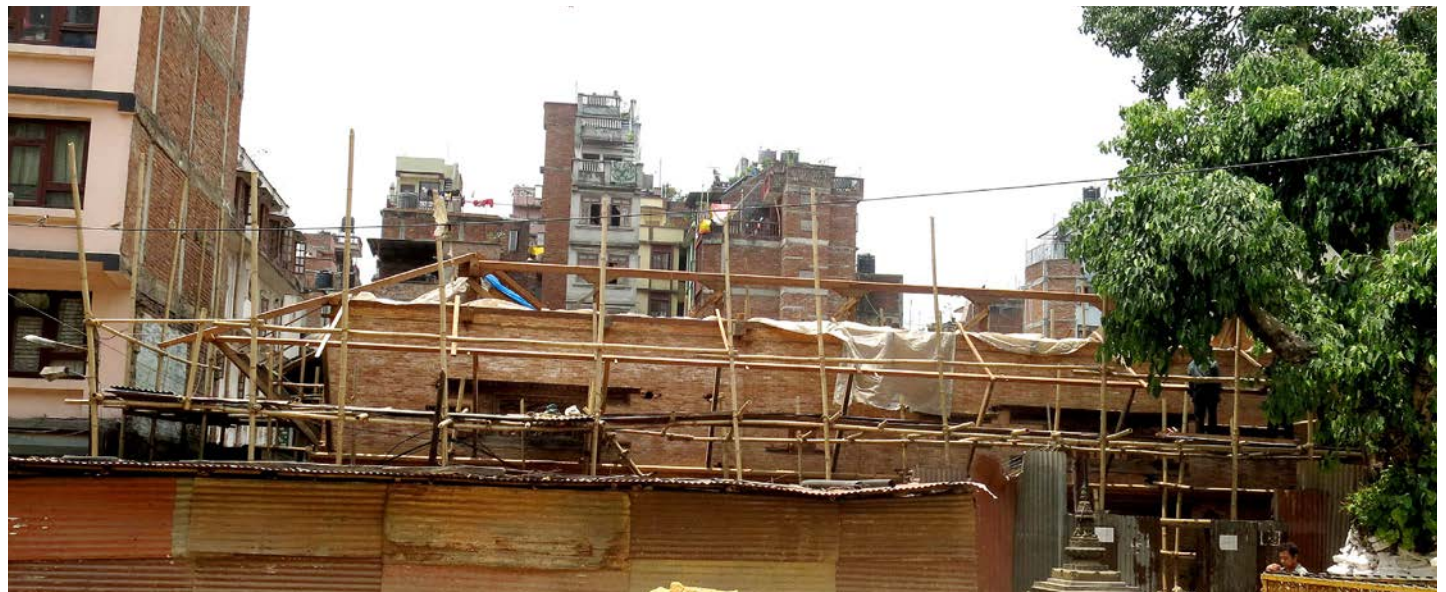
Itumbaha East Wing | May, 2016
 Roof rebuilding initiated with the installation of base wood, pillars, capitals and ridge beam. Mason building partition wall with traditional *ma-apa* brick in mud mortar on southeast corner. Roof rebuilding continued by installing corner, valley rafters and purlins (*chalu*).

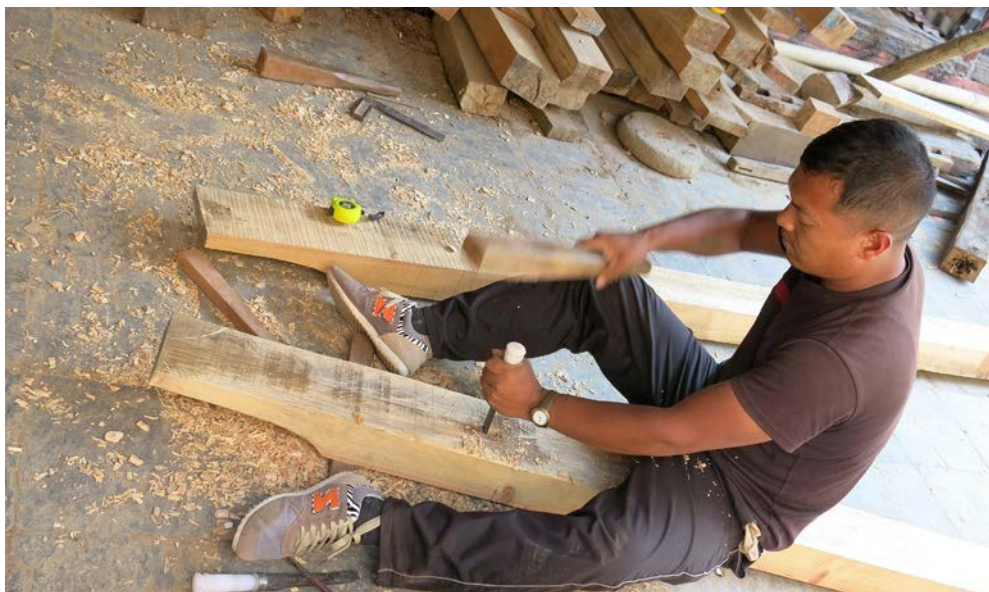
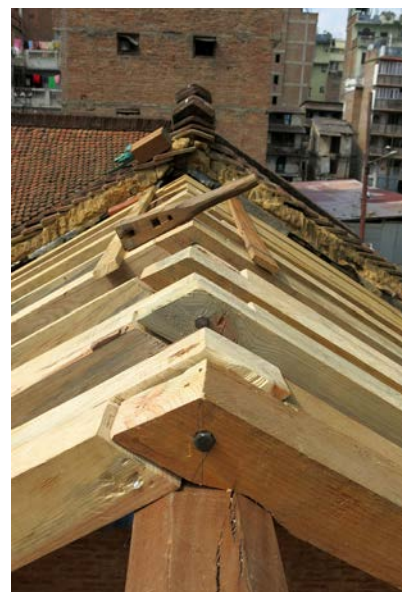
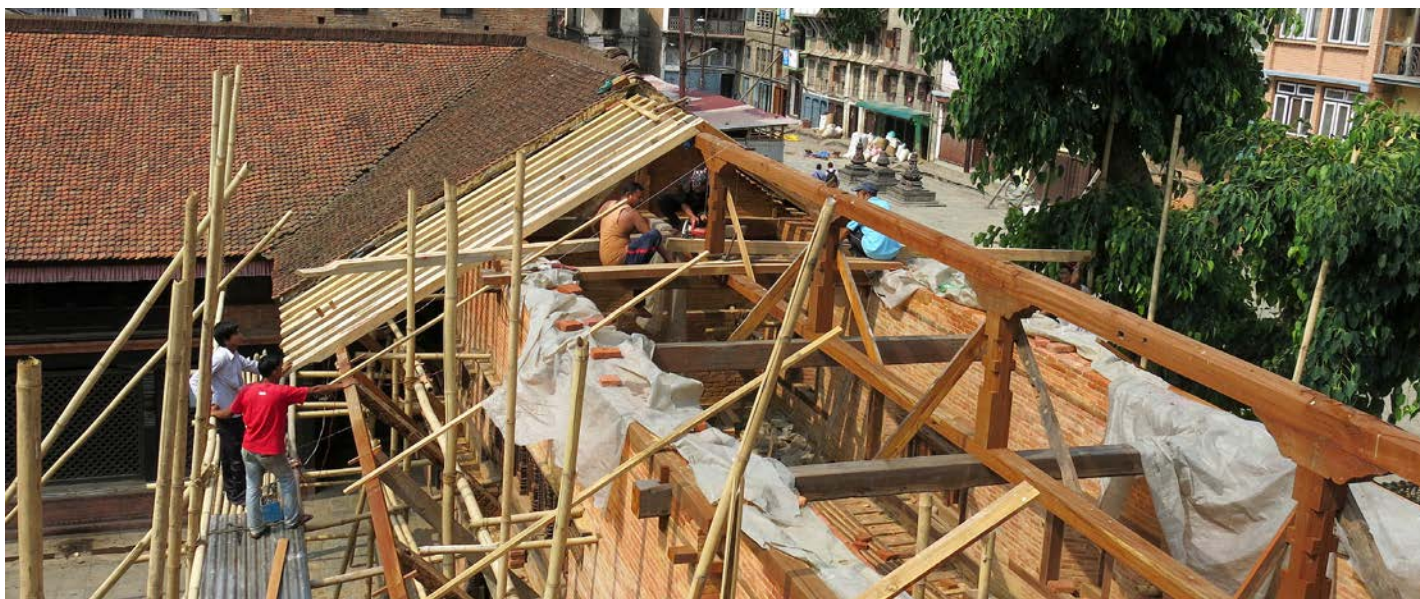
Itumbaha East Wing | May, 2016
Carpenter making holes for inserting timber peg (*cuku*) on rafters. Roof rebuilding continued by installing rafters. Nut bolts are installed to tie two opposite side rafters on ridge level.
