THE RESTORATION OF
ITUM BAH
FINAL REPORT | OCTOBER 2017

SUBMITTED TO ORIENTAL CULTURAL HERITAGE SITES PROTECTION ALLIANCE, FRANCE

IMPLEMENTED BY THE KATHMANDU VALLEY PRESERVATION TRUST

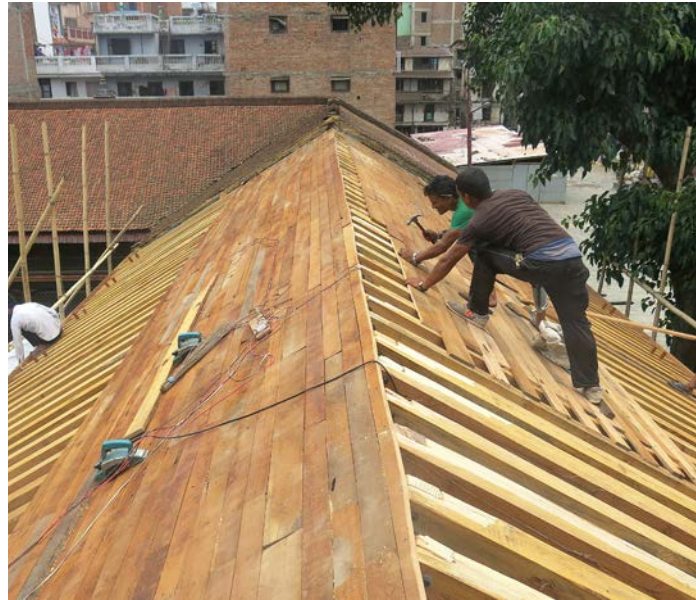
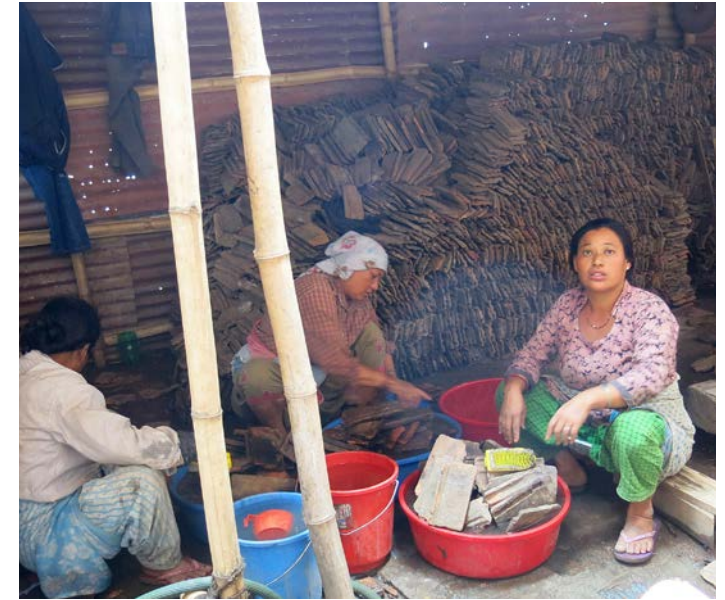
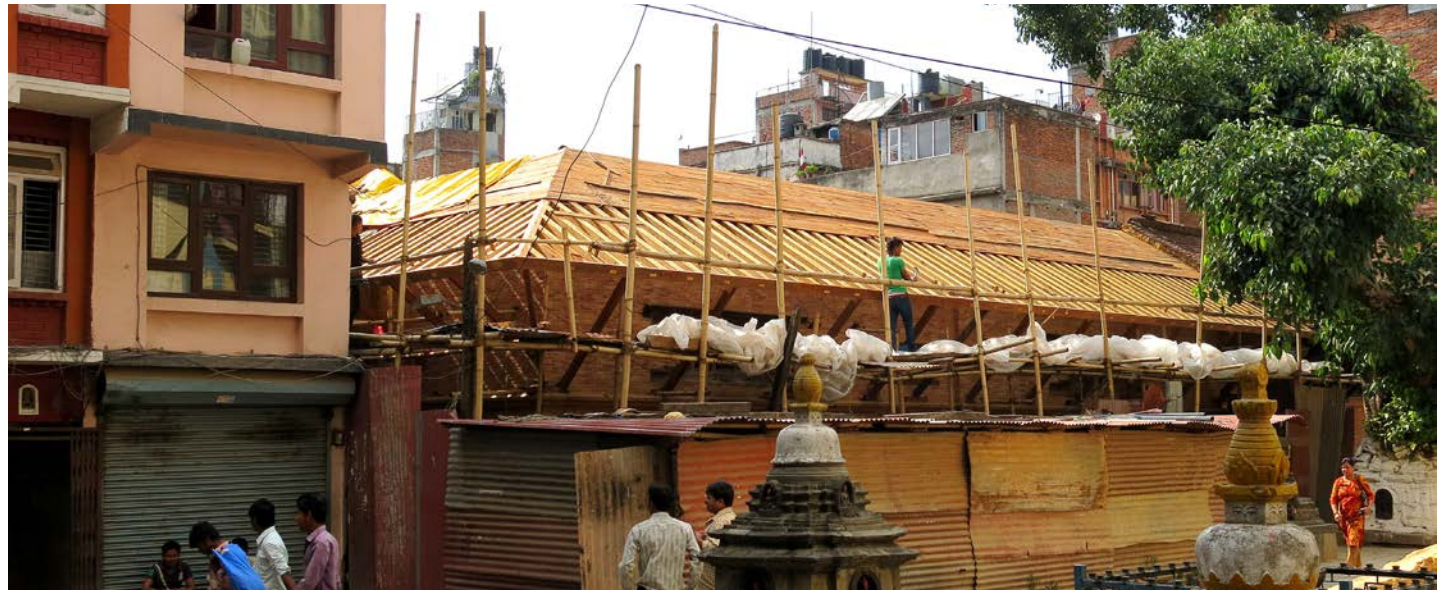
Itumbaha East Wing | June, 2016
A view of ongoing roof reconstruction from southeast corner, after the installation of rafters completed including *sal* wood planking over the rafters.

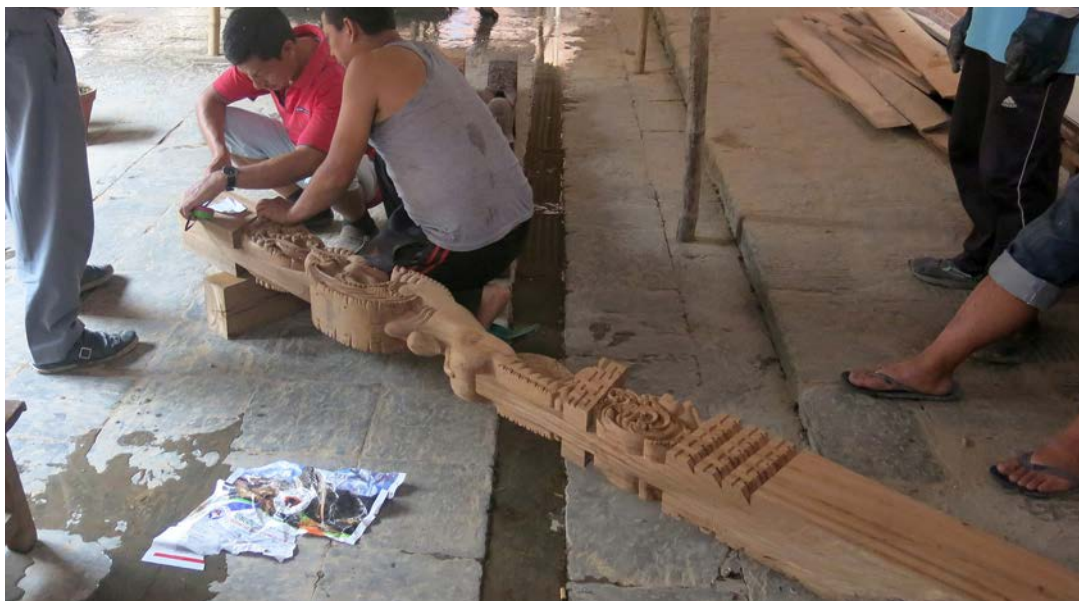
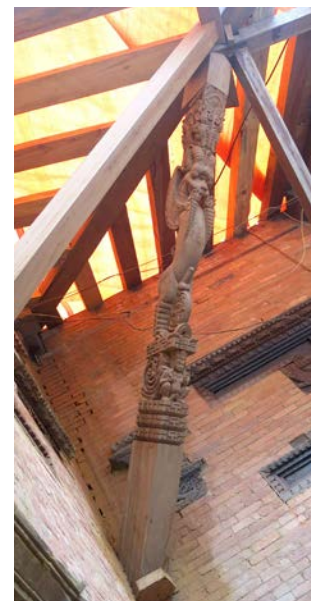
Itumbaha East Wing | June, 2016
Woodcarvers preparing the newly carved corner strut for installation. Installation of newly carved corner roof struts completed in southeast corner of courtyard and principal facade.

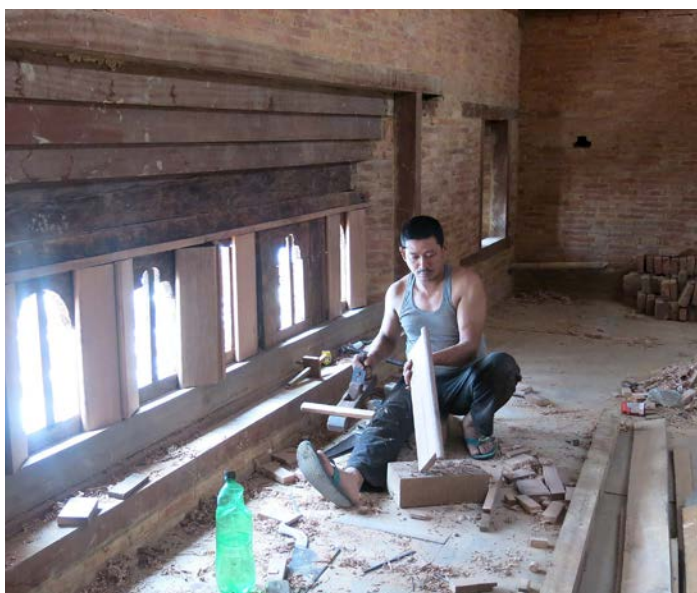
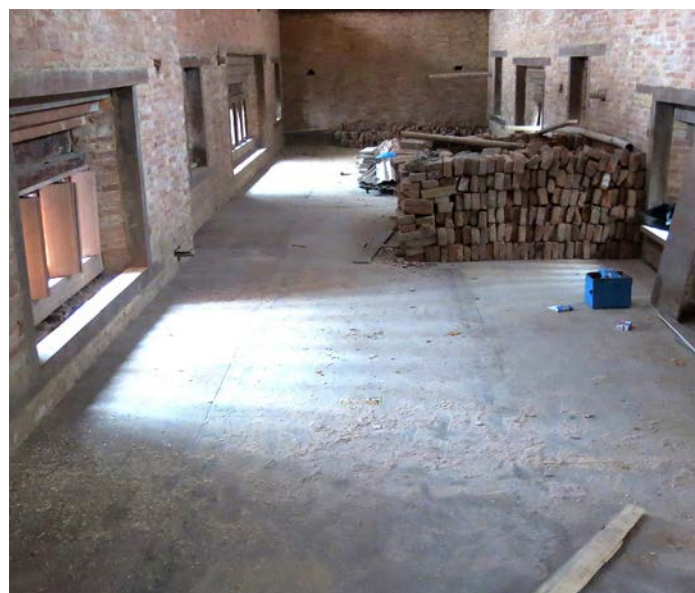
Itumbaha East Wing | June, 2016
Carpenter making the new *sal* wood window panel of *pasukajhya* and installing it. A view of first floor level after the installation of waterproof plywood completed.

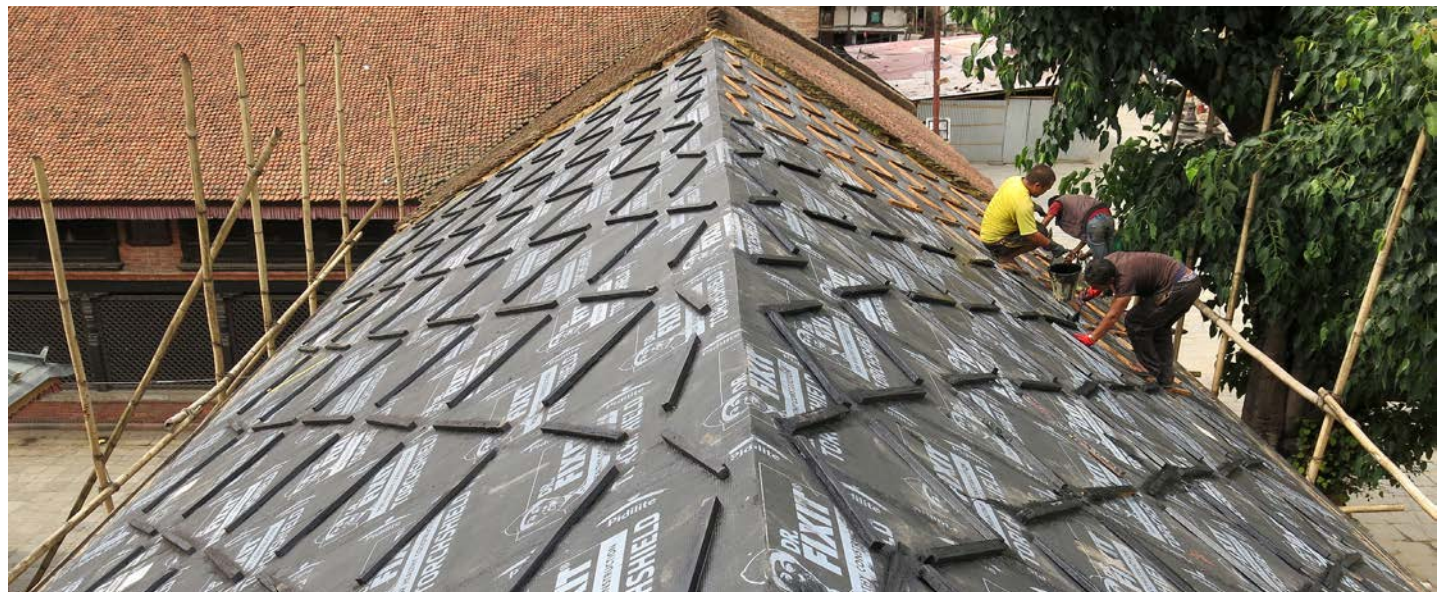
Itumbaha East Wing | July, 2016
Waterproofing membrane *hyperplas* is being laid over the *sal* & terracotta planking (*kothapau*) on the roof including timber batten. The angled wooden bats helps prevent the mud base of the tile roof from sliding down.

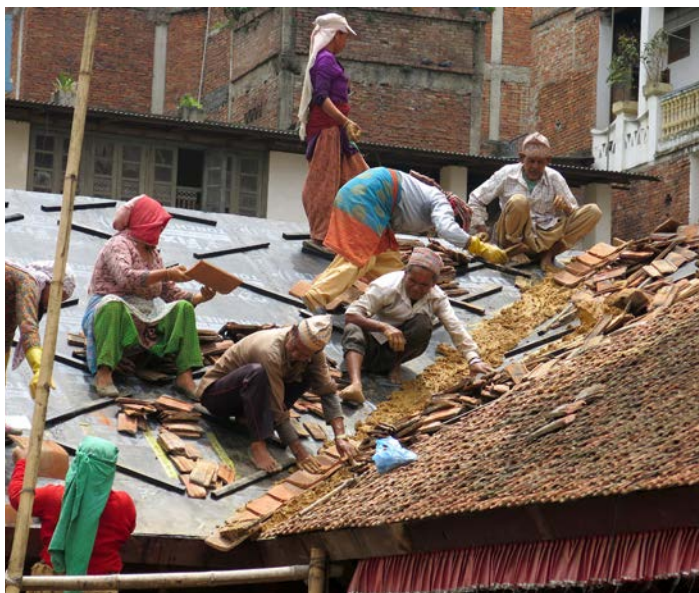
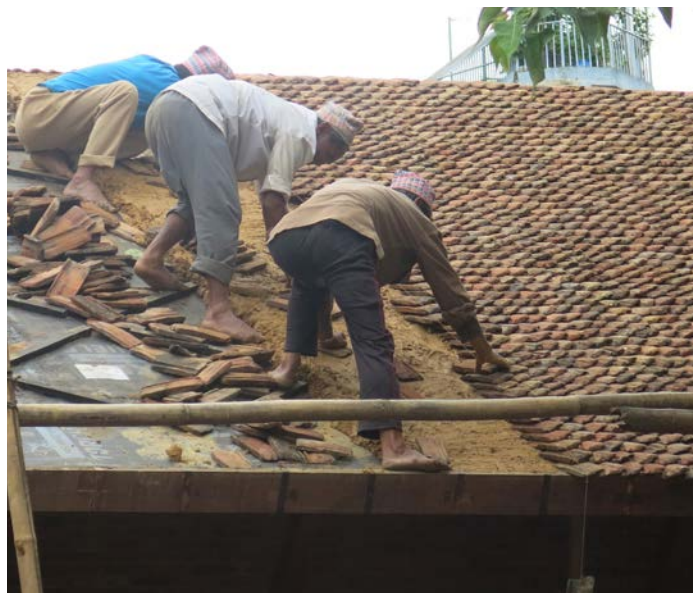
Itumbaha East Wing | July, 2016
Laying traditional roof tile (*ayapa*) over the yellow mud bed is initiated from courtyard side south part. Roof layers laying of traditional roof tiles above the main roof. The tiles are laid on top of a layer of yellow mud below which are the waterproofing membrane hyperplas sheets over sal and terracotta planking.

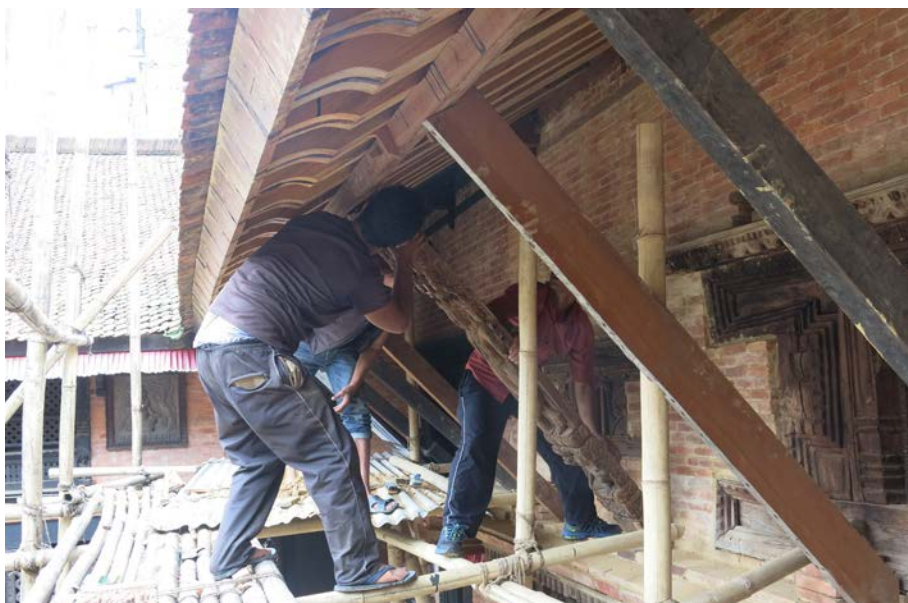
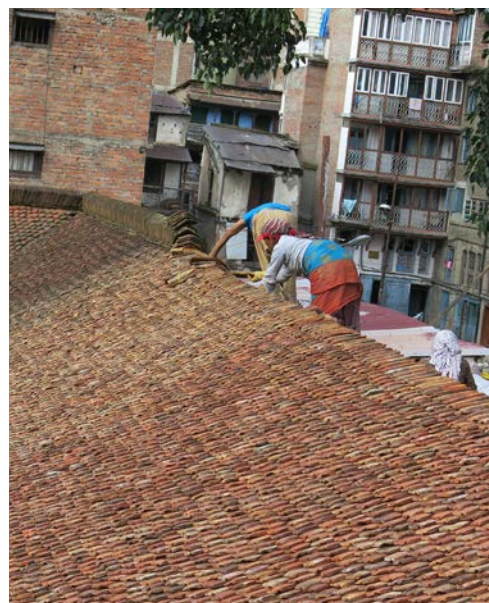
Itumbaha East Wing | July 27, 2016
Carpenters installing the repaired roof struts on the courtyard side. Workers laying ridge tiles as final step of roof tile laying after completion of the traditional roof tile.

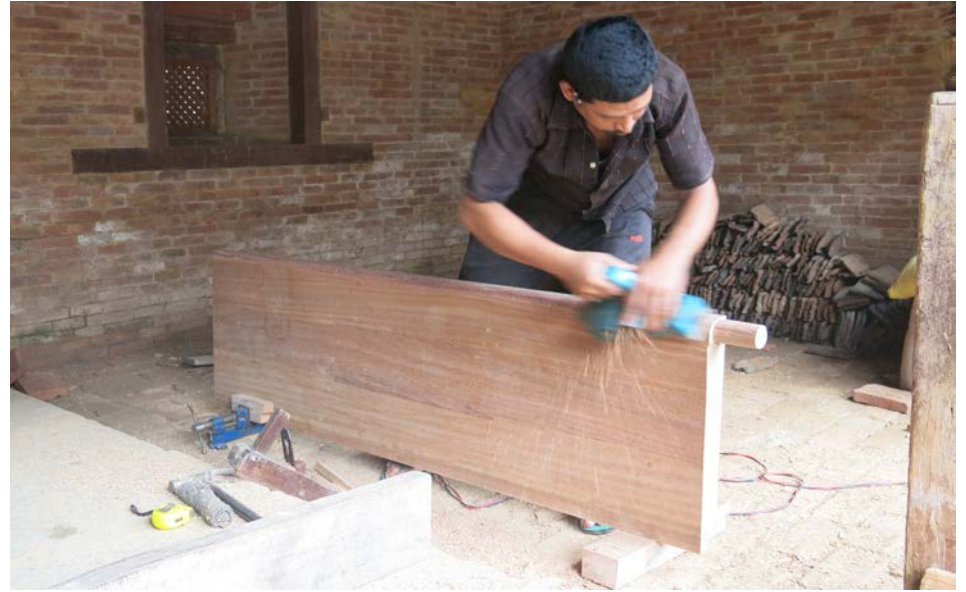
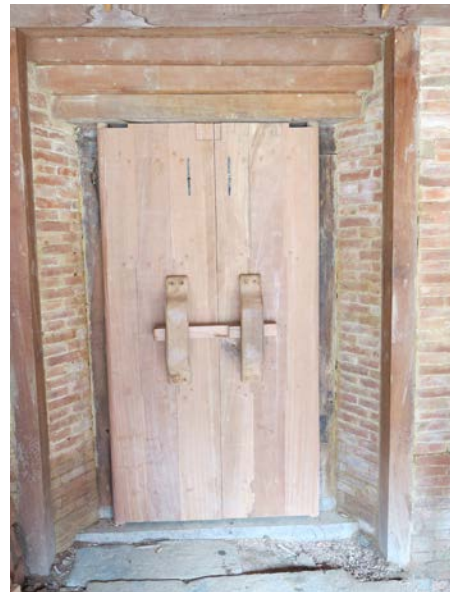
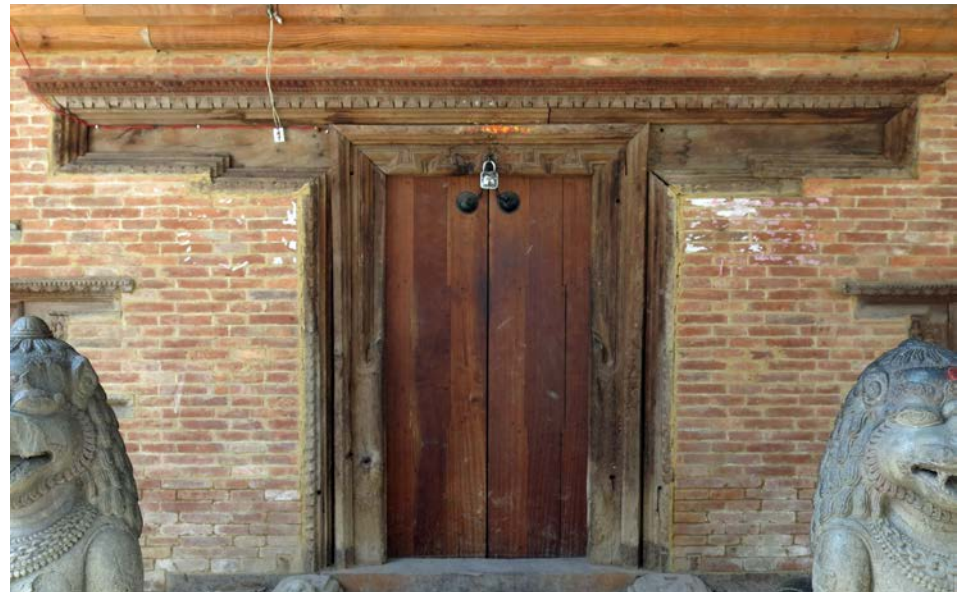
Itumbaha East Wing | July, 2016
Carpenter making and installing new door leaf for
the main entrance on the east side.

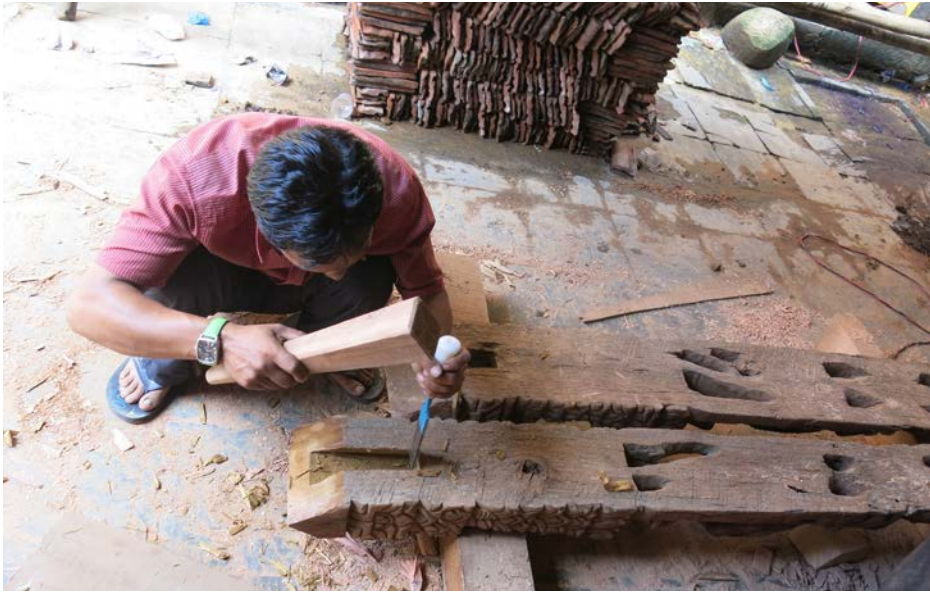
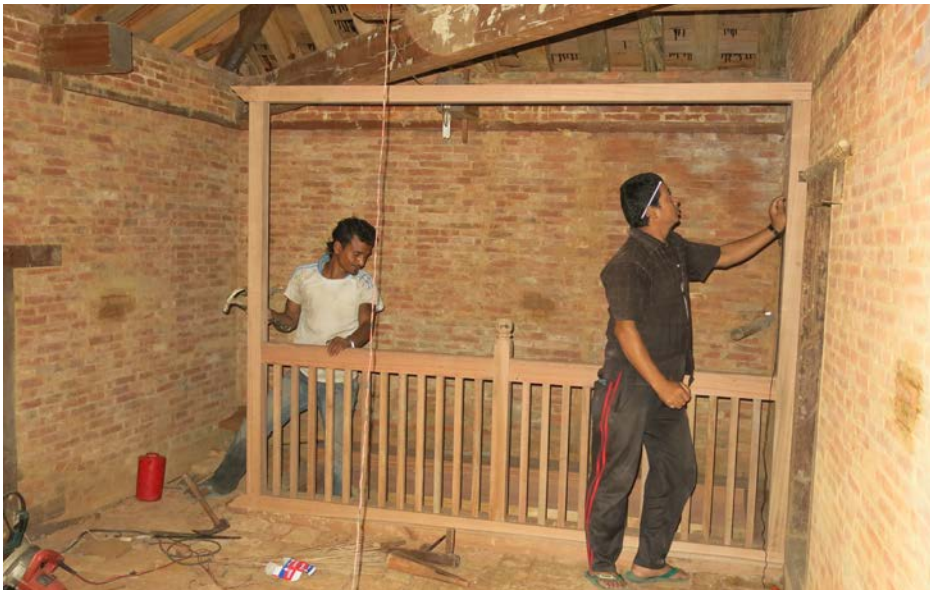
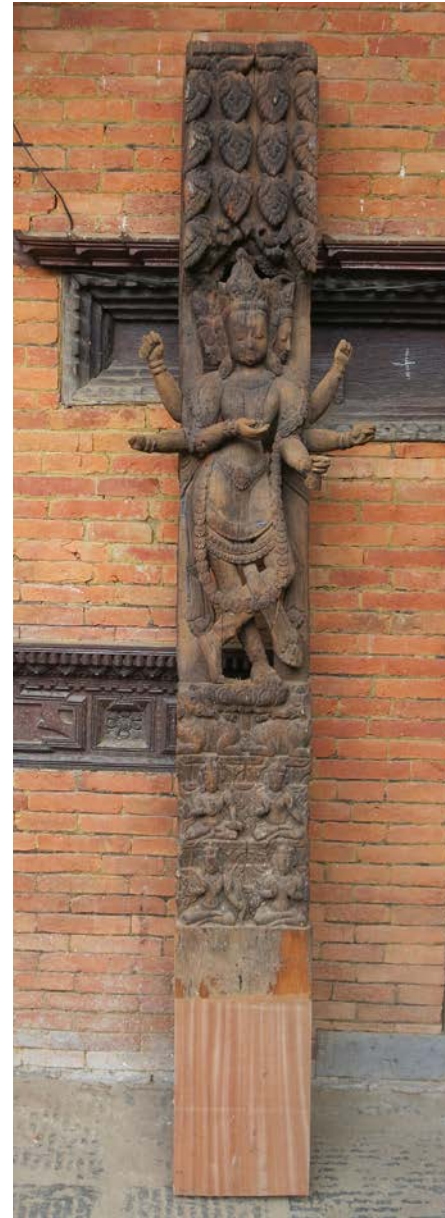
Itumbaha **East Wing** | July, 2016
Carpenter repairing and replacing damaged portion of the struts with new timber piece.
Installation of the railing in the first floor level staircase opening.

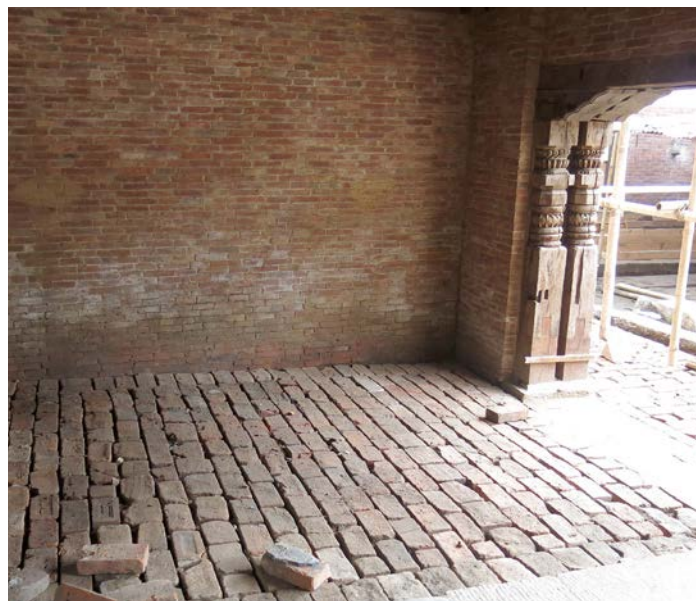
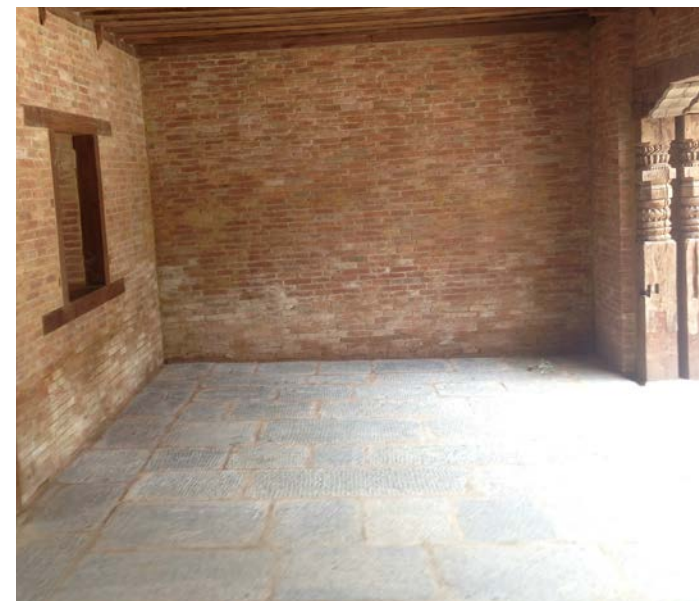
Itumbaha East Wing | August, 2016
Flat brick soling completed on the first floor level over the joist and planking where traditional floor tile *cikan-apa* was laid. Preparation of lime surkhi mortar for brick soling and laying of new terracotta floor tiles in lime surkhi mortar has started in the first floor.

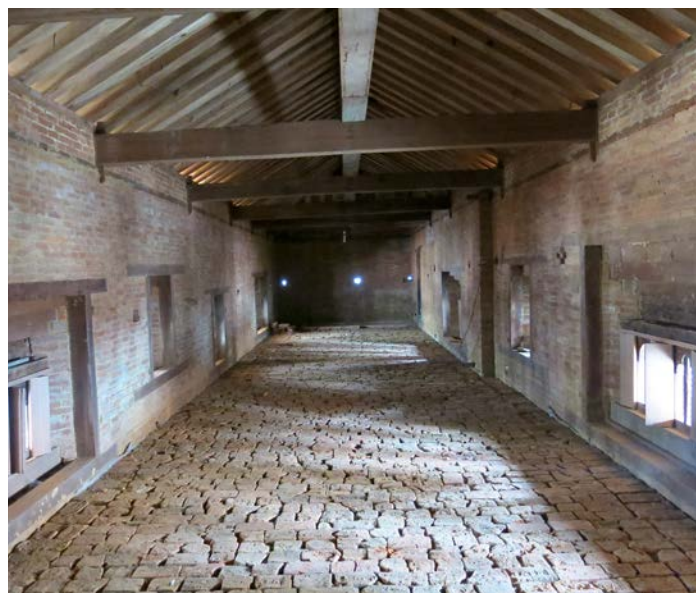
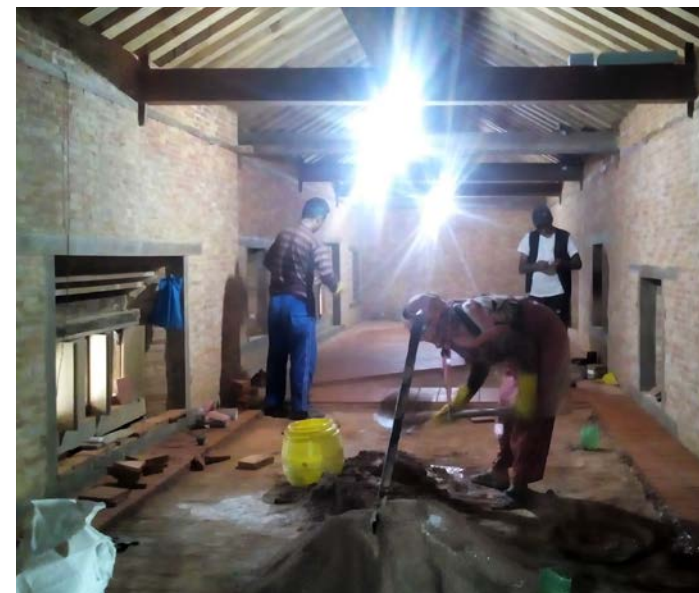
Itumbaha East Wing | Sept, 2017
Laying of new terracotta floor tiles in lime surkhi mortar has been completed in the first floor. All the historical windows are fitted with new inner frames as the original ones were damaged beyond repair. Mud plaster has been applied on the walls.

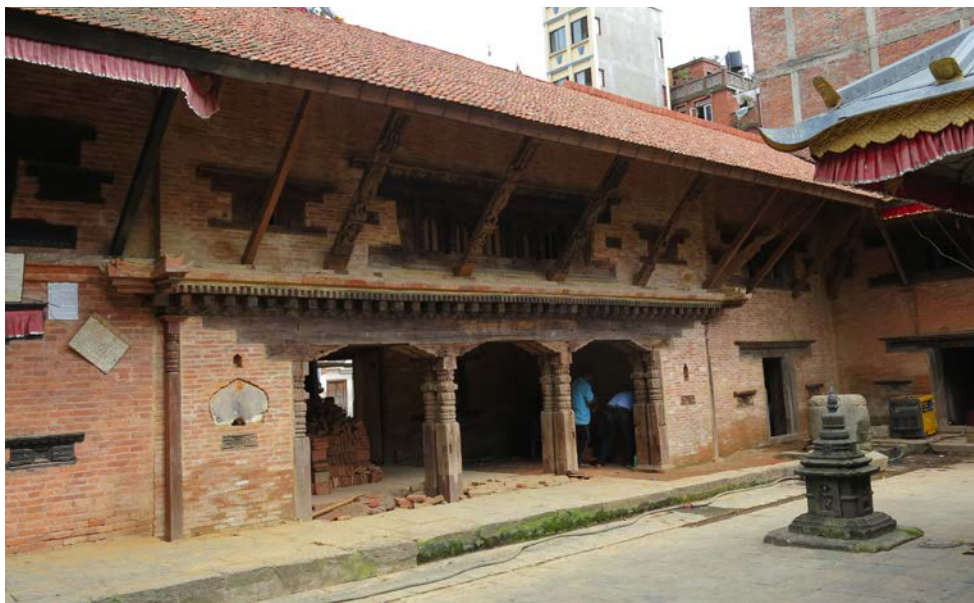
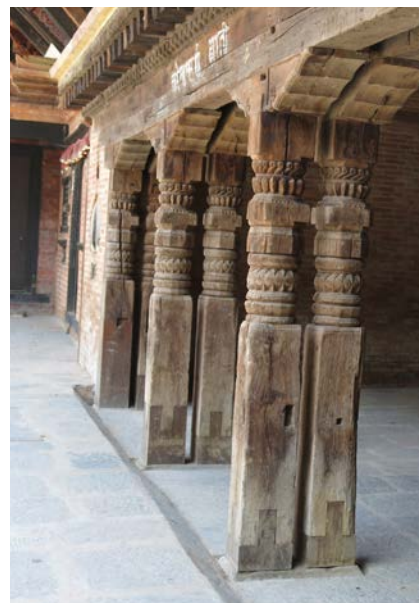
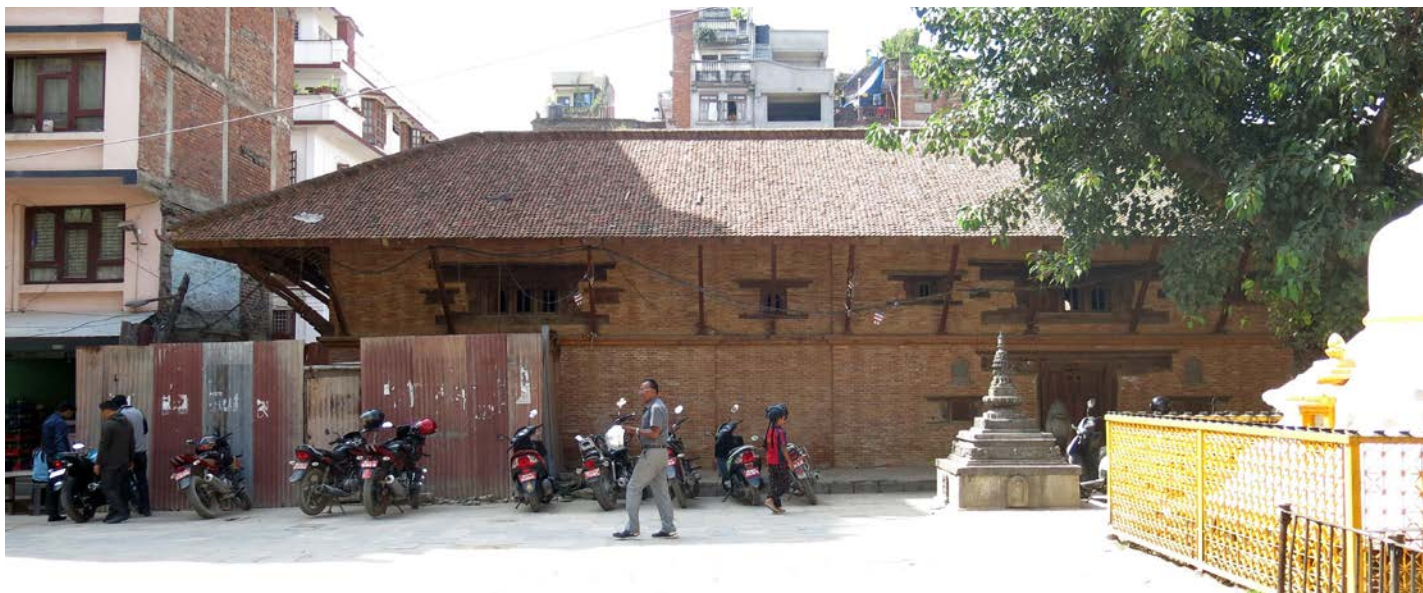
Itumbaha East Wing | Aug, 2016 & Sept 2017
A courtyard view and exterior view of east wing
after all restoration work has been completed.

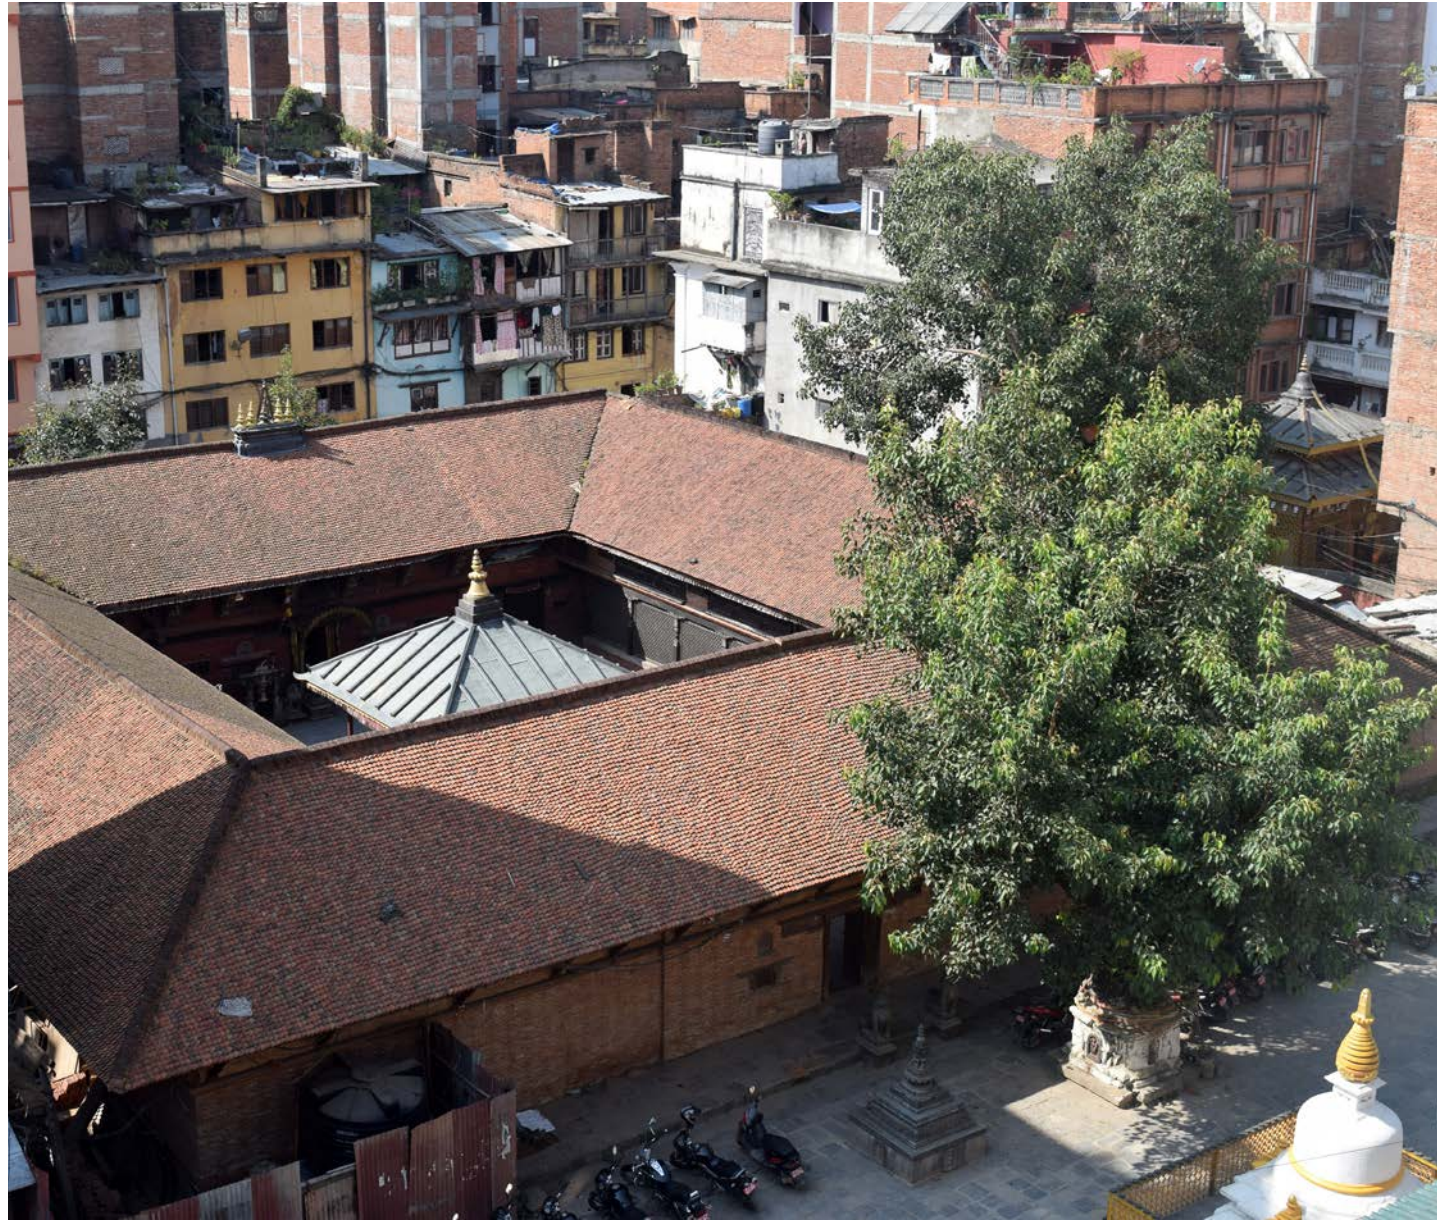
Itum Baha East Wing | Sept 2017
Itum Baha east wing after completion of all
restoration work.
